# Silverton Wind Farm

Independent Environmental Audit – Action Response Plan

# SITE REHABILITATION PLAN

Project Name:	Silverton Wind Farm
Doc No.:	J880-PLN-040

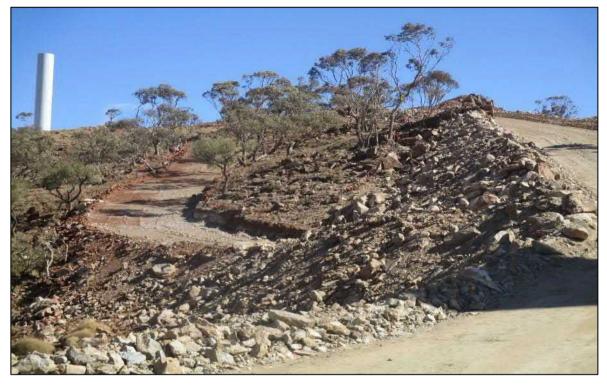
*Photo: Underground HV electrical trench between T34 and T35 (Area 7): Bench to be retained and rehabilitated to minimise disturbance to Porcupine Grass Sparse Woodland.*

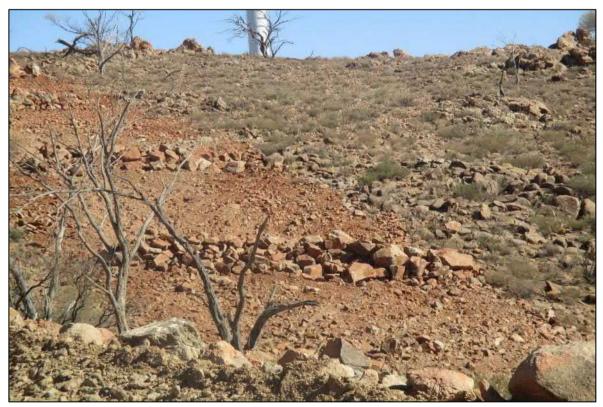
Photo: Underground HV electrical trench between T07 and T08: Rehabilitated with rock barriers or diversion banks installed to control and disperse any downhill water flow.

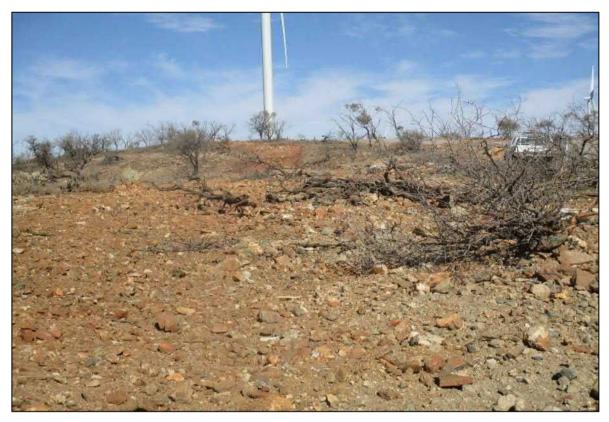
Photo: Underground HV electrical trench between overhead line and T52: Rehabilitation complete.

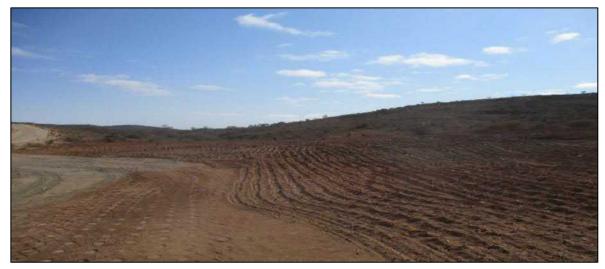
Photo: Rehabilitated storage/traffic turn-around area.

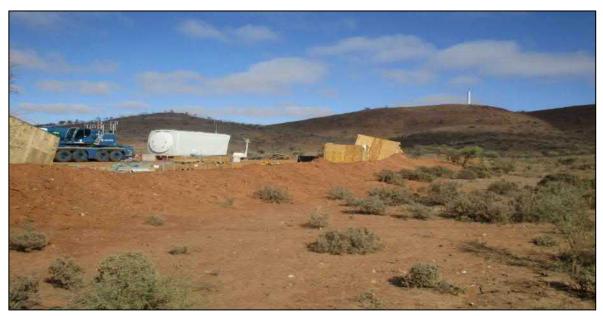
Photo: Equipment laydown area with stockpiled topsoil, awaiting rehabilitation.

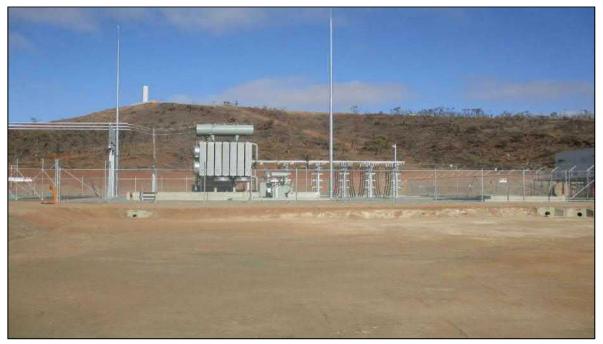
Photo: Electrical Substation, with rehabilitation works commenced.

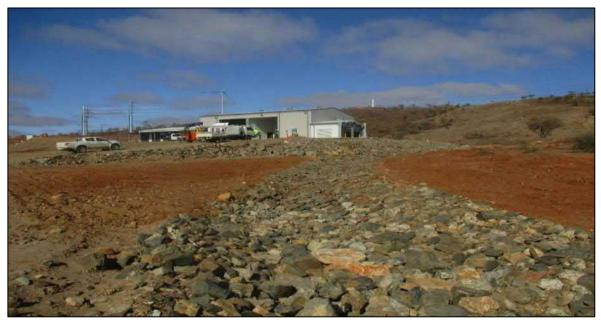
Photo: Operations and Maintenance Facility, with rehabilitation works commenced.

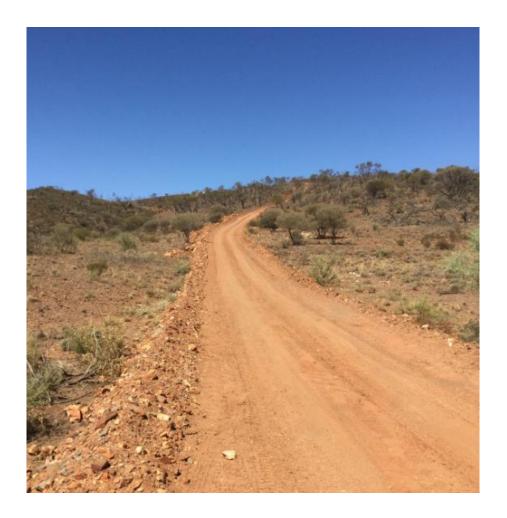
No ERSED cut off drains along OHL access track to CN2B. *ERSED* controls to be installed as per Blue Book guidelines for all OHL track's. OUTSTANDING.

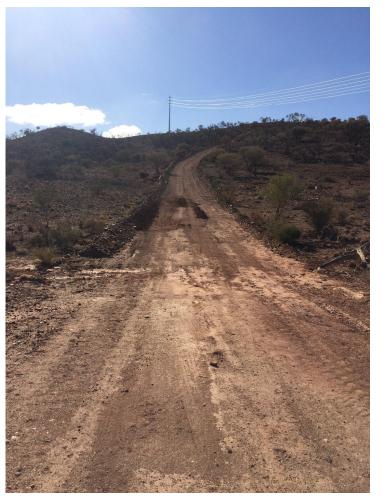
Access track as of 16/8/2018. Action item still open.

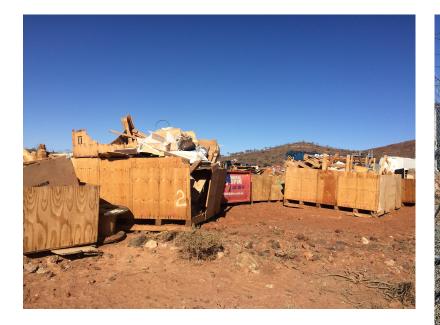
Item 1 - Overflow of contained waste at Saren's laydown requiring segregation and disposal. *Segregate waste and undertake review need for more frequent pickups by waste subcontractor.*

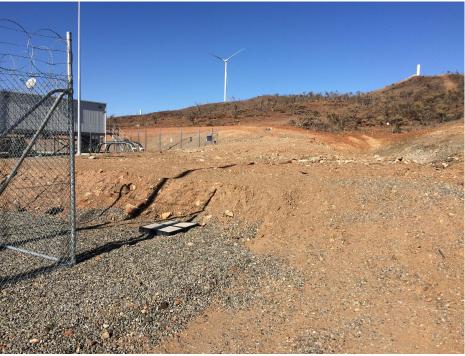
Item 2 – Rehabilitation of area behind 33kv substation (GE Catcon area) not undertaken. *Topsoil dressing and contour ripping of area required as a priority due to exposed area adjacent to realigned watercourse possing a erosion risk.*

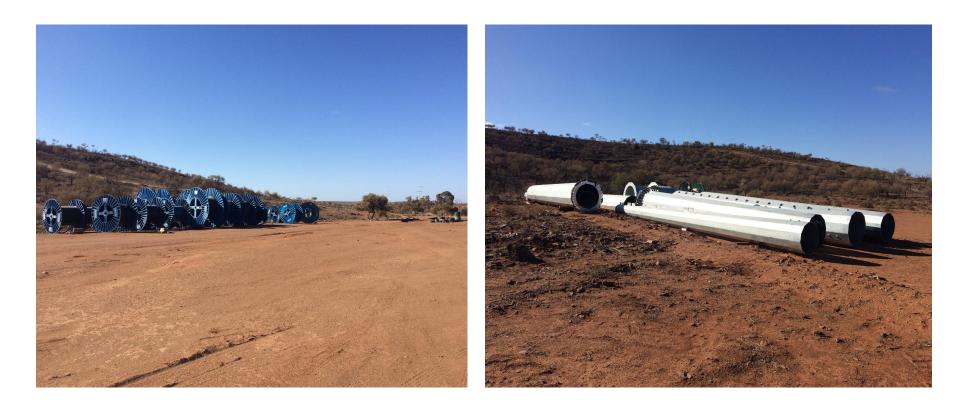
Item 3 - large laydown areas pose a increased erosion risk. Stored cable drums and excess overhead poles to be relocated to suitable laydown so rehabilitation can commence.

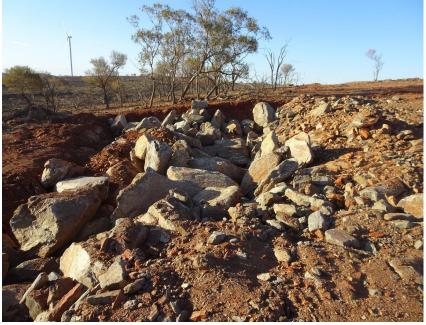
Item 4 (Above) - Micro sited turbine footing pad (Area 4) with rock / disturbed depression with no ERSED controls. *Reuse rock and /or rehabilitate site.*

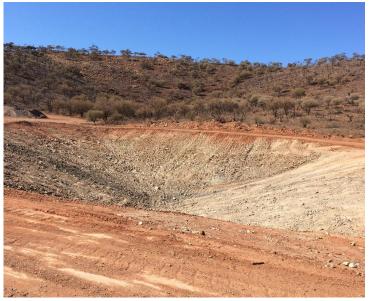
Item 5 (adjacent) - Borrow areas and unused laydown areas across site pose erosion risk. *Sites to be planned for rehabilitation.*

Photo - Material borrow located within Area 7

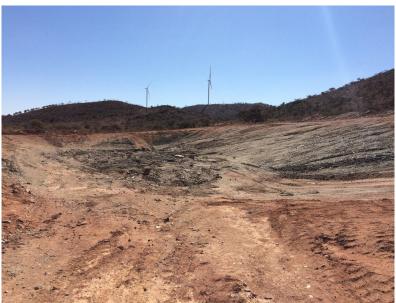
Photo - Material borrow located within Area 2

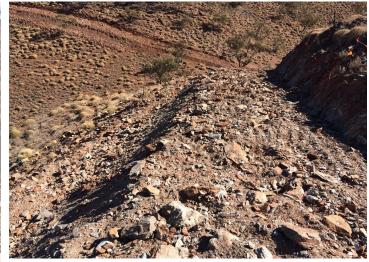
Rehabilitation attempts between T32 to T30 to be reviewed again with contractor if further reshaping can occur to a more natural profile. As disturbance is within the Porcupine Grass Sparse Woodland CEEC this is a highly sensitive location for importance of rehabilitations of native species.

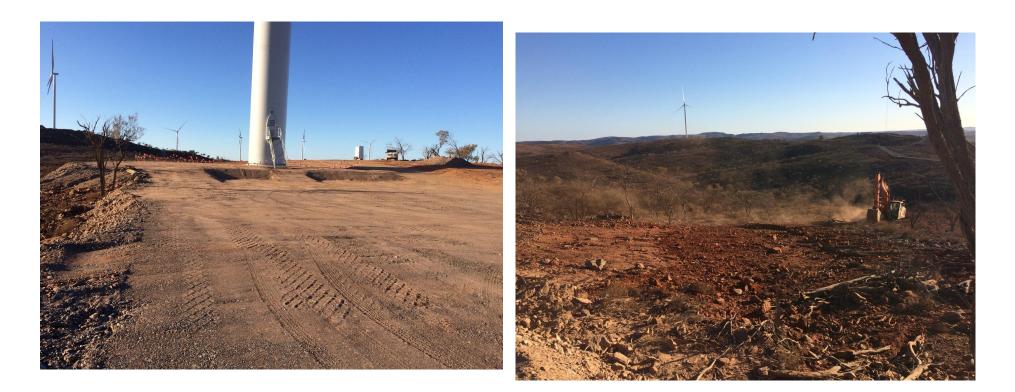
T23 proofed rolled and ready for punch listing

Photo - Rehabilitation works of HV line adjacent to T23. *JACOBS* recommend toolbox of all operators undertaking rehabilitation on presence of heritage sites in proximity and for operators to stay within disturbed areas only.
