Coopers Gap Community Consultative Committee (CGCCC)

Coopers Gap Wind Farm Project CGCCC Meeting 12

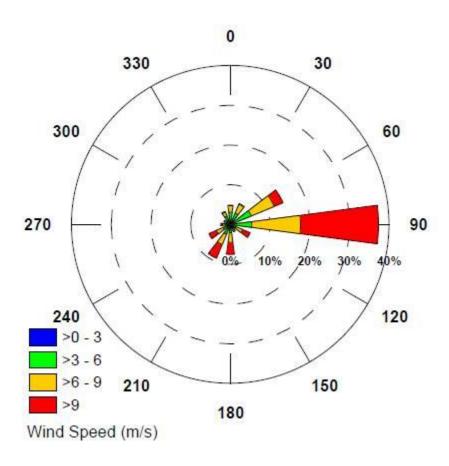
Wind Rose - Coopers Gap Wind Farm. March 2006 - April 2012
