# Appendix I Soils and Contamination Specialist Study

# Newcastle Power Station

Soils and Contamination  
Specialist Study

2019-10-11

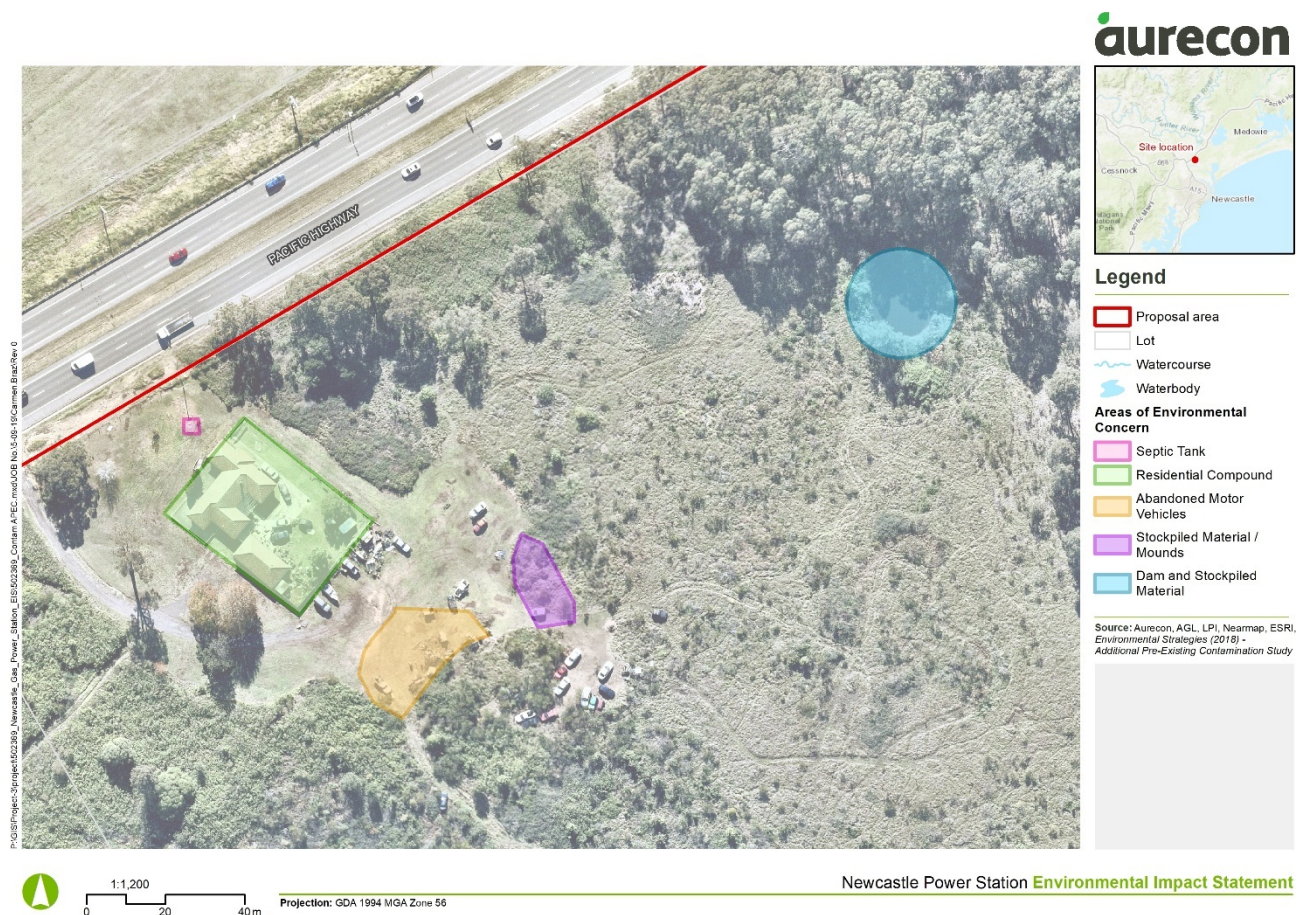
Figure 5-1 AECs from ES, 2018

The identified AECs and all site investigation and sampling locations are presented in **Figure 5-1** and **Figure 5-2**.

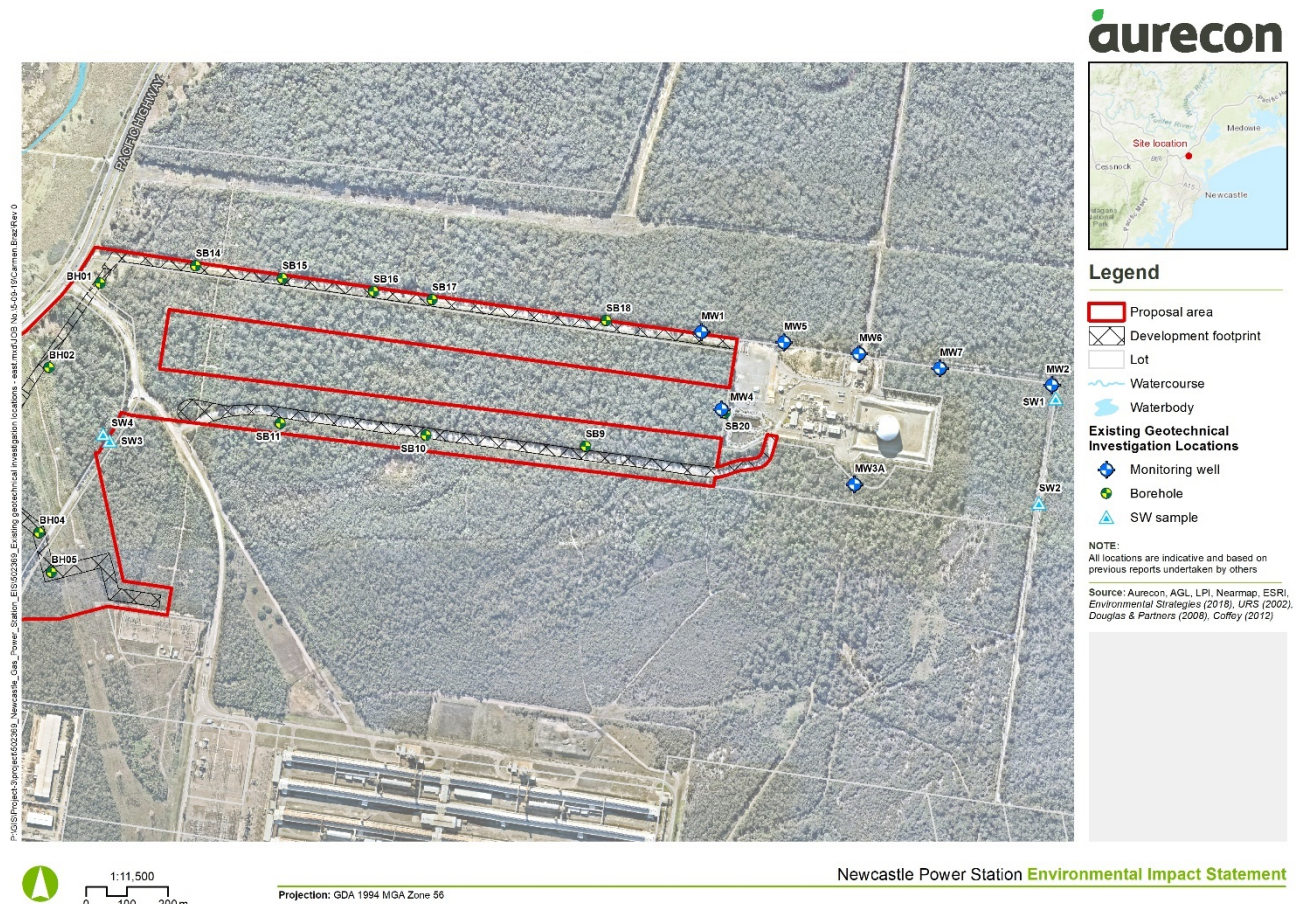
**Figure 5-3 Environmental assessment site investigation locations (Coffey, 2011) (note – legend to be updated splitting out separate consultant’s investigation locations)**

All Coffey 2011 site investigation and sampling locations are presented in **Figure 5-3**.

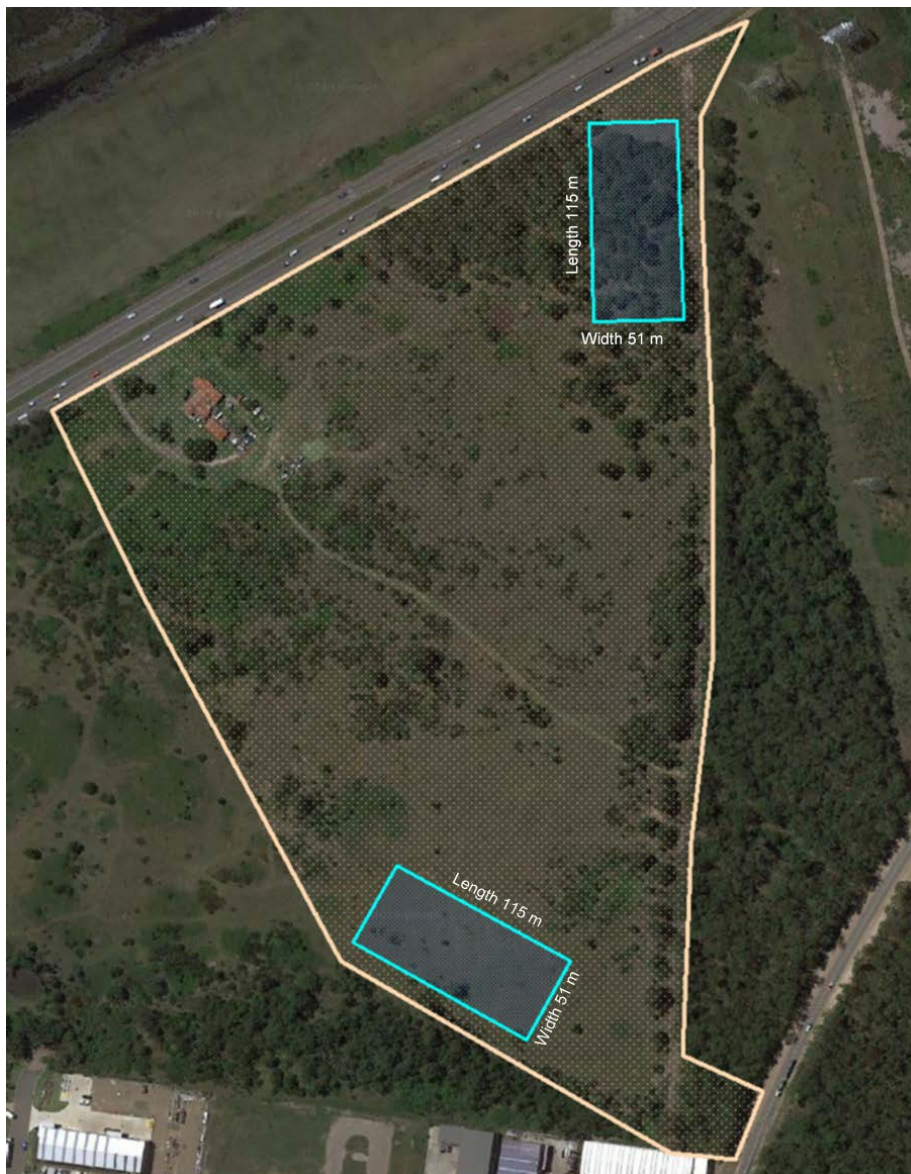
**Figure 6-2 Approximate basin footprint sizes**

The feasibility study suggested the two basins were constructed as detailed in Figure 6-2 below. This is a conservative estimate of the total footprint sizes of each basin based on the total disturbed area during construction.

Permitted the sediment basins as described in detail in the feasibility study are implemented during the construction phase, sedimentation is not anticipated to enter the nearby waterways and impact upon the nearby Ramsar wetland. During design of the sediment basins reference should be made to the feasibility study, in particular the assumptions to ensure adequate design and effectiveness of the sediment basins.

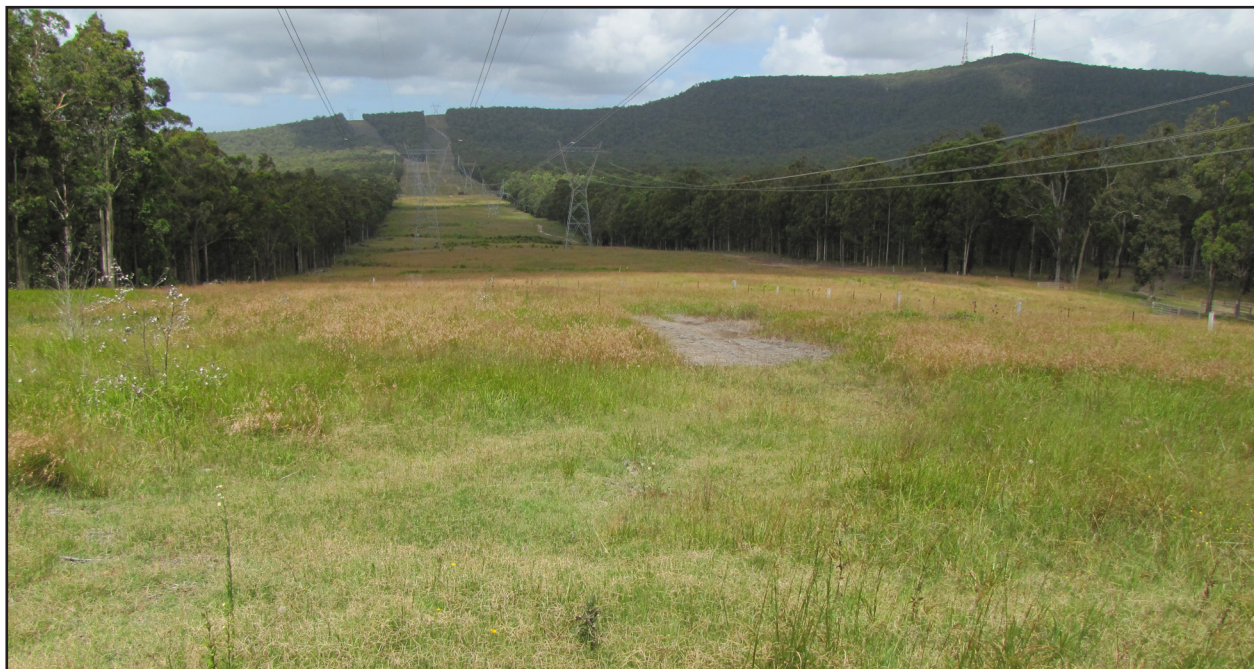
## BERESFIELD

**Landscape**—undulating low hills and rises on Permian sediments in the East Maitland Hills region. Slope gradients 3–15%, local relief to 50 m, elevation is 20–50 m. Partially cleared tall open-forest.

**Landscape Variant**—*bea*—steeper upper slopes (15–<25%).

**Qualities and Limitations**—high foundation hazard, water erosion hazard, Mine Subsidence District, seasonal waterlogging and high run-on on localised lower slopes, highly acid soils of low fertility.

Generally high foundation hazard due to moderate to high shrink-swell (reactive) and highly plastic subsoils. Topsoil depth is 5–50 cm. Total soil depth is <120–>200 cm.

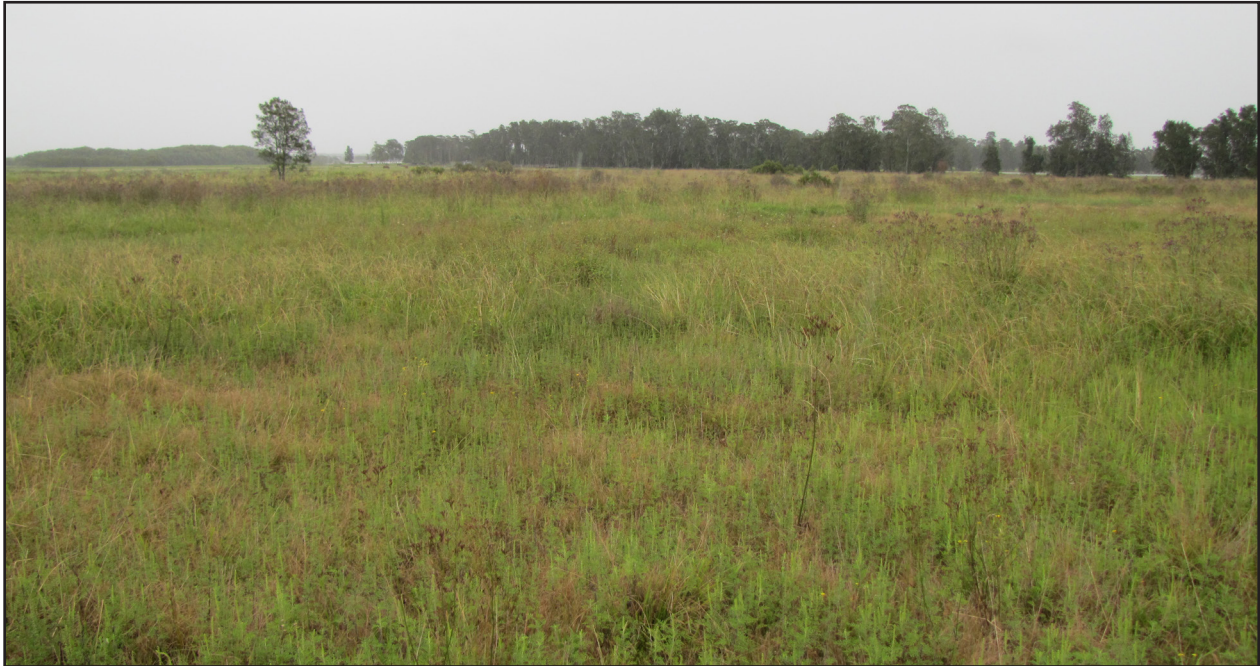
## MILLERS FOREST

**Landscape**—extensive alluvial plain on recent sediments in the Hunter Plain region in the centre of the sheet. Elevation is 6–3 m, local relief is <1 m, slope gradients are <1%. Cleared tall open-forest.

**Soils**—deep (>150 cm), imperfectly to poorly drained Prairie Soils (Gn3.21, Gn3.23).

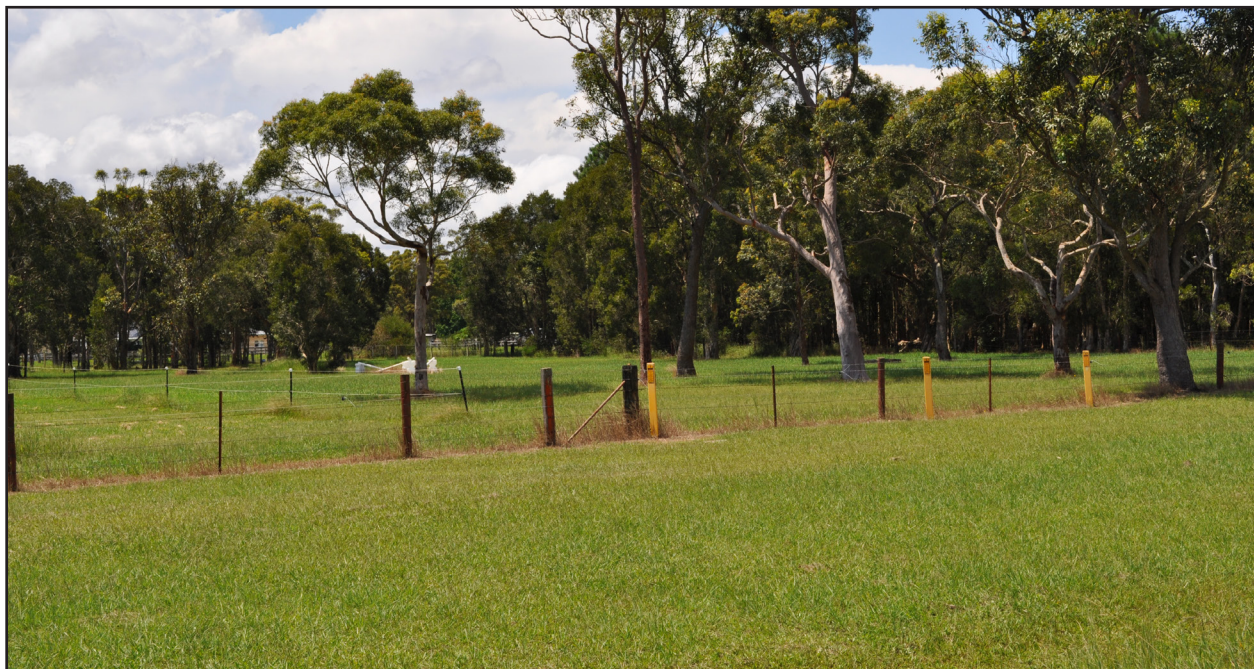
## SHOAL BAY

**Landscape**—Pleistocene sandsheets and low dunes on the Tomago Coastal Plain. Slope gradients generally <15%, local relief <10 m, elevation <15 m. Partially cleared tall open-forest.

**Landscape Variant—sba**—steep high dunes.

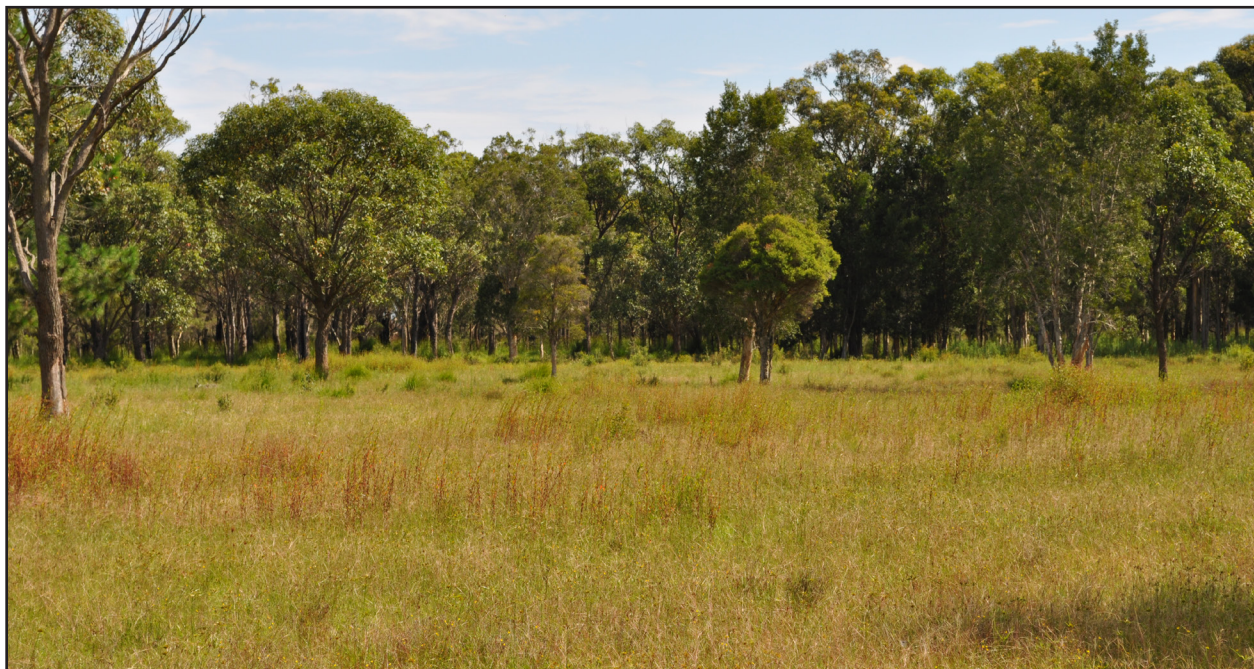
## TEA GARDENS

**Landscape**—Pleistocene beach ridges on the Tomago Coastal Plain. Local relief <1 m, slopes <5%, elevation 5–8 m. Uncleared dry and wet heath.

**Landscape Variant—tna**—Pleistocene sandsheets with wet heath forest.
