Visual Impact Verification Report

NYNGAN SOLAR PLANT

MARCH 2016

Project Title: Nyngan Solar Plant

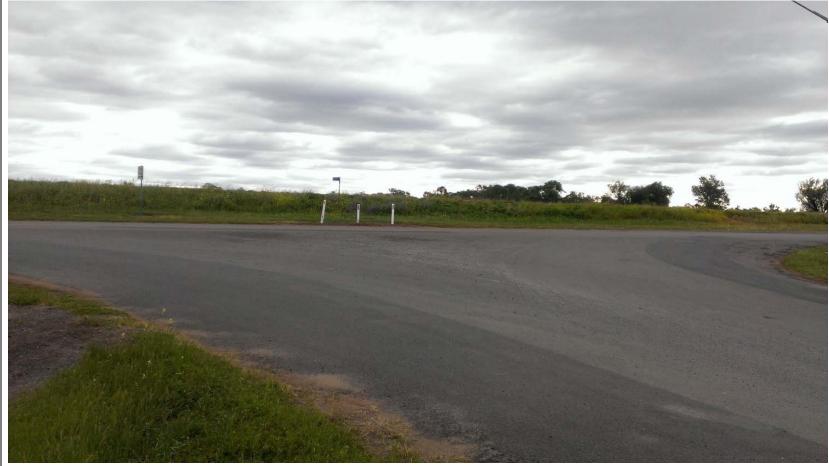
Viewpoint	Visual impact significance (2012)	Comments (2012)	Verification (2015)
V3 Tottenham Road (public)	Low	Development unlikely to be seen	Visited 8 September 2015. View from corner of Tottenham Road and Oatley Street, south western area of Nyngan township. Development not visible.
8km from

8km from site

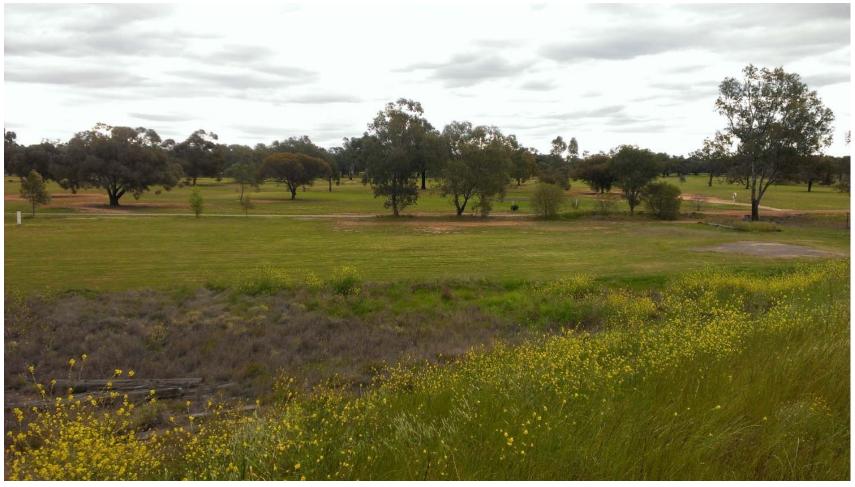
Viewpoint	Visual impact significance (2012)	Comments (2012)	Verification (2015)
V4 Nyngan Golf Club (public)	Low	Development unlikely to be seen	Visited 8 September 2015. View from levee bank adjacent to Golf Club, south western extent of Nyngan township. Development not visible.

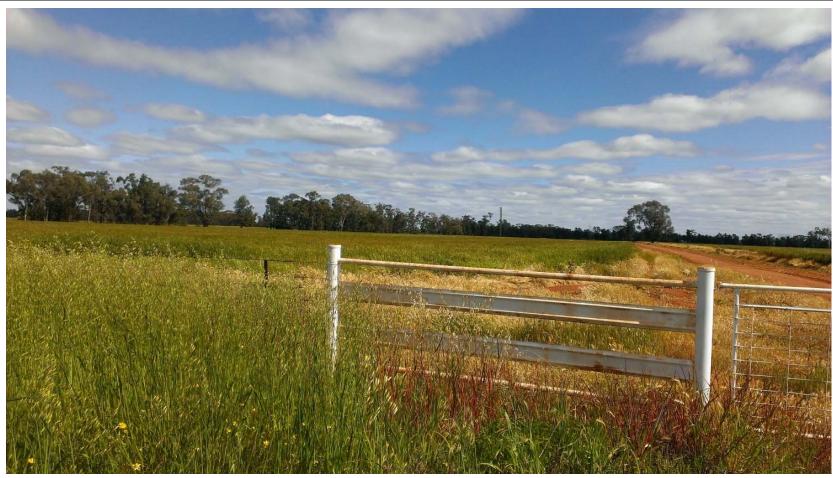
Viewpoint	Visual impact significance (2012)	Comments (2012)	Verification (2015)
V10 Mitchell Highway –	Low	Development barely visible if seen at all	Visited 8 September 2015. View from Mitchell Highway approx. 7km west Nyngan. Development not visible.
(public)

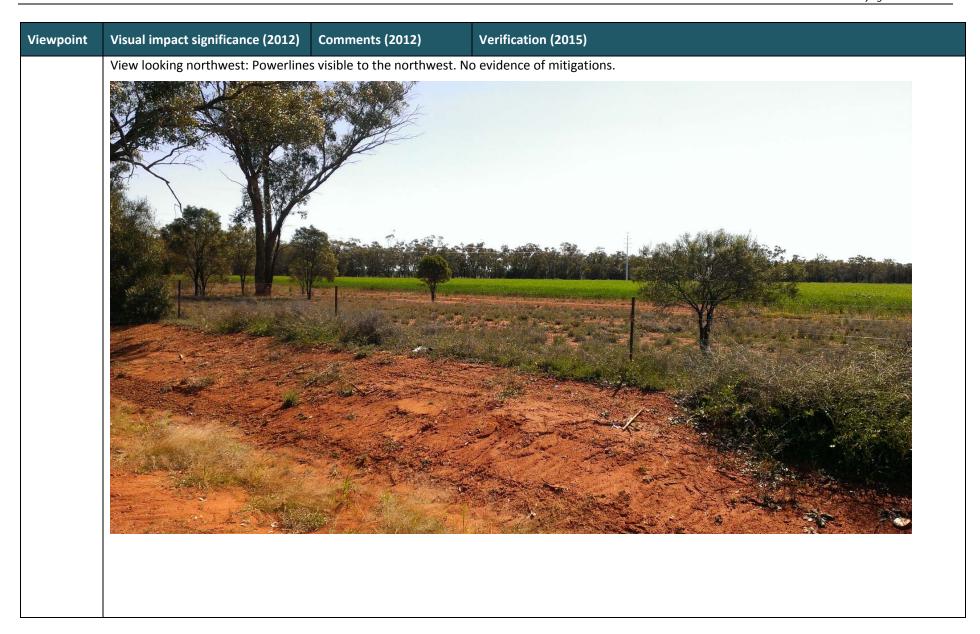
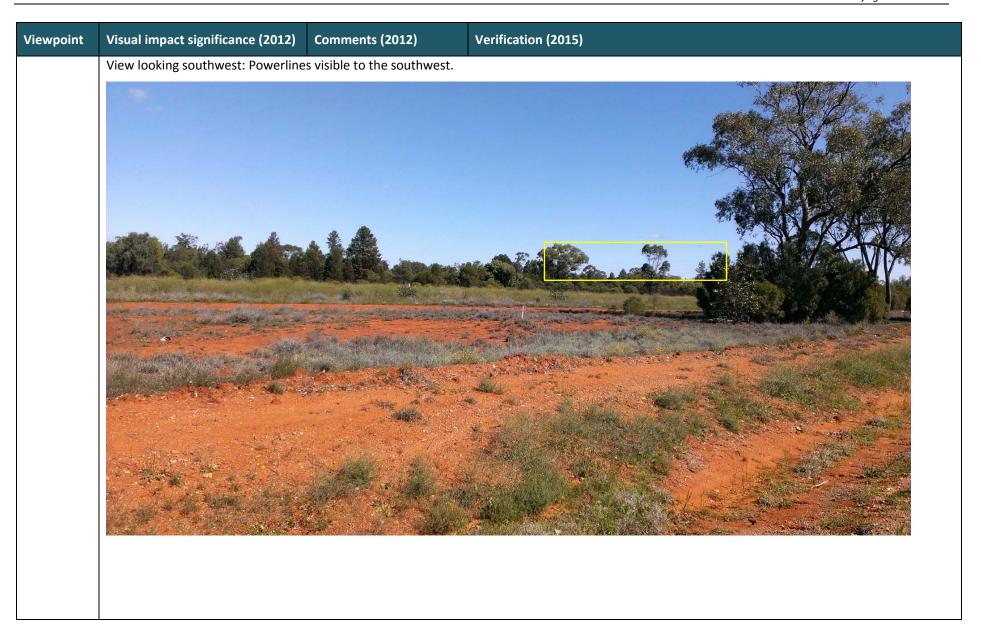
Viewpoint	Visual impact significance (2012)	Comments (2012)	Verification (2015)
V15 Barrier Highway line crossing	Low	Poles and wires visible close to crossing point, mitigation suggested	Visited 9 September 2015. Comments at various locations below.
(public)	View looking west: Powerlines visi proposed poles were 26m tall, insta		est, as per 2012 photomontages. Power poles appear smaller than 2012 montage as ground.
200m to road crossing, 1.8km to substation and solar plant

2. Use shorter poles for the transmission line (approximately 15m high is desirable) to reduce the contrast in height between the poles and the existing trees (feasibility subject to detail design requirements, reliable visual effect).	2. Yes	2. Shorter poles have been used – 20.8m.

Viewpoint	Mitigation opportunities (2012 VIA)	Implemented	Comment
	4. Minimise clearing for easement on southern side of highway and retain shorter shrubs where possible (feasible but requires co-operation from landowner and authorities).	4. Yes	4. Powerline easement is slightly east of that in 2012 maps — this location required clearing of fewer trees.

The 2012 VIA noted low visual impact significance for all viewpoints, with mitigation measures suggested for Viewpoints 15 and 17. Table 3-2 lists suggested mitigation opportunities, of which some have been implemented. For Viewpoint 15 the project design changes included the use of shorter power poles to be placed as far from the highway as possible, minimising clearing of the transmission line easement to reduce visual impacts and using a dark, neutral colour for the site office walls and roof. It appears the transmission line poles have been offset from both sides of highway and poles heights have been determined by the road and railing crossings. The site office building walls and roofs are light neutral colours, however these are barely visible from Viewpoint 15.

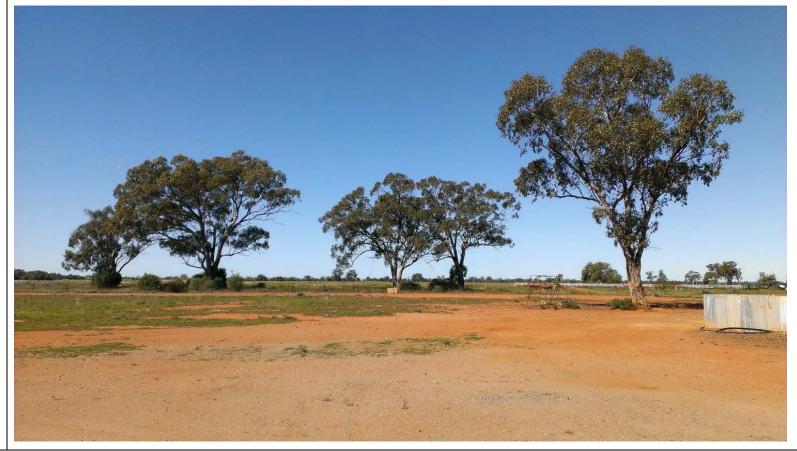
Viewpoint	Visual impact significance (2012)	Comments (2012)	Verification (2015)
V16 Tikkara house (private)	Low	Development unlikely to be visible	Visited 9 September 2015 Tikkara farmhouse remains surrounded by trees and shrubs toward the north (in direction of solar plant) and west (in direction of transmission line) so that views are screened by large blocks of existing vegetation.
4.01	6

1.8km from View from Tikkara homestead toward the most open views to the east:

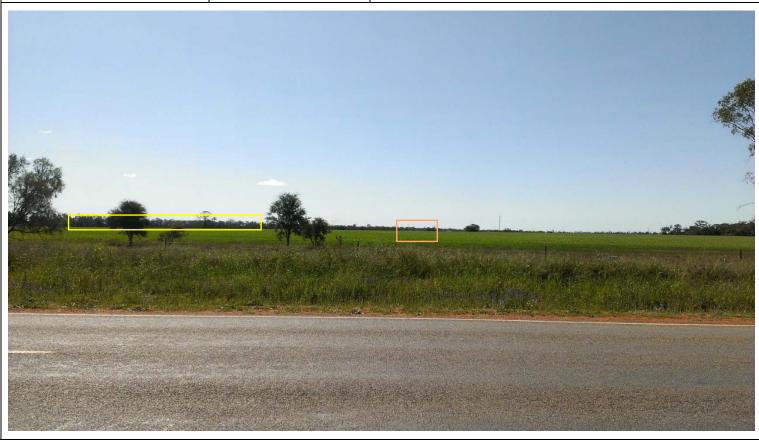
Viewpoint	Visual impact significance (2012)	Comments (2012)	Verification (2015)
V17 Barrier Highway – Tikkara (public)	Low	Solar plant barely visible in distance, mitigation suggested	·

5. Establish strategically located endemic trees and shrubs to screen views from highway to substation and site office.	5. No	5. No planting evident.
	6. Select a dark, neutral colour for the site office walls and roof to assist them to blend with dark colours of nearby tree canopies.	6. No.	6. Light neutral colours. Verified 9/9/15
16	None	N/A	Verified 9/9/15
17	Establish endemic trees and shrubs in gaps in roadside vegetation immediately adjacent to site.	1. No	1. Planting not implemented.

2. Establish screening shrubs, growing to at least 2m high, along the southern edges of the solar plant.	2. No	2. Planting not implemented.
			Verified 9/9/15

To mitigate the visual impact of the transmission line, substation and site offices on views from the Barrier Highway, landscape planting options to screen views were suggested in the 2012 VIA. NGH understand that planting is planned to be undertaken over autumn and winter 2016.

The views from the Barrier Highway of the transmission line, substation and site office are seen fleetingly through gaps in roadside vegetation from moving vehicles. This will be minimised through the implementation of the landscape planting proposed, which will require consultation with Roads and Maritime Services.
