Independent Environmental Audit Silverton Wind Farm

January 2019

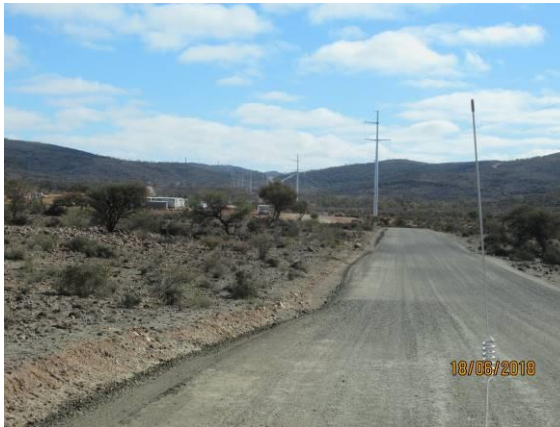
Photo #	Comment	Photo
Photo 1.	Access to the Silverton Wind Farm site offices with transmission line on right of photo.

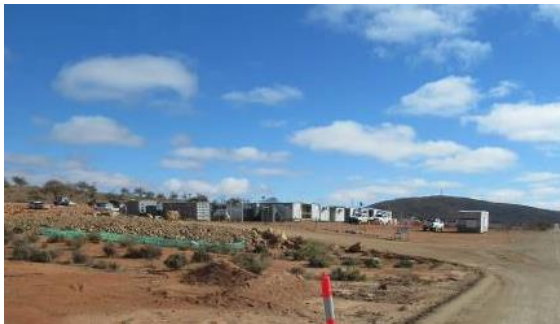
Photo 2.	Silverton Wind Farm site offices

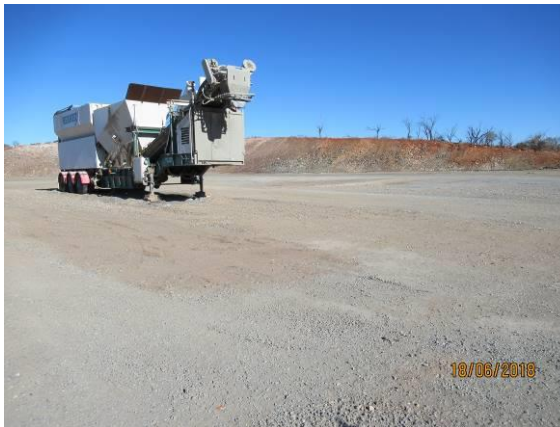
Photo 3.	Crusher at crushing pad ready for removal. Crushing operations were complete at the time of the audit. The crushing pad was still to be rehabilitated.

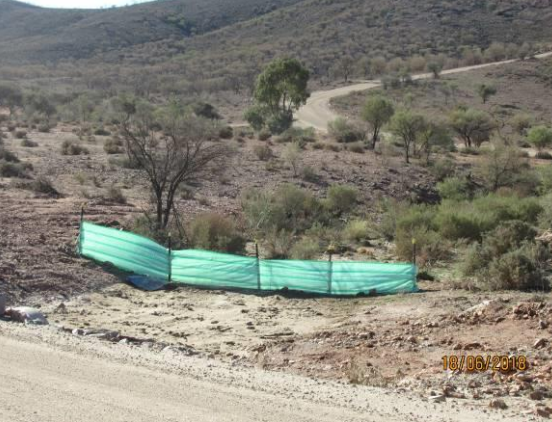
Photo #	Comment	Photo
Photo 8.	Sediment fence in downstream side of the creek (above).

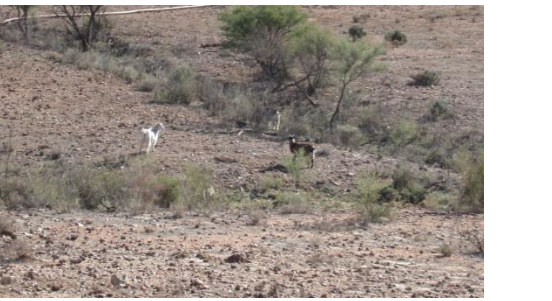
Photo 9.	Wild goats were seen commonly across the site during site inspections.

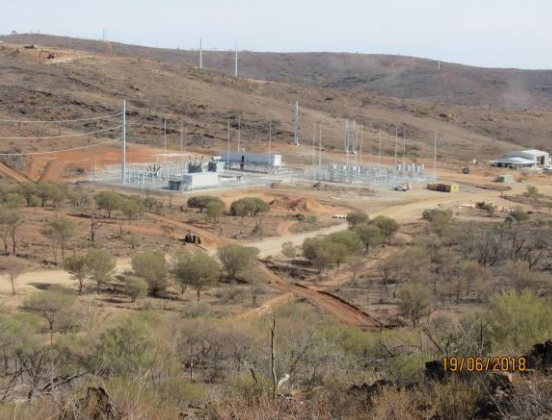
Photo 10.	Substation in operation. Some construction/landscaping and drainage works were continuing around the substation.

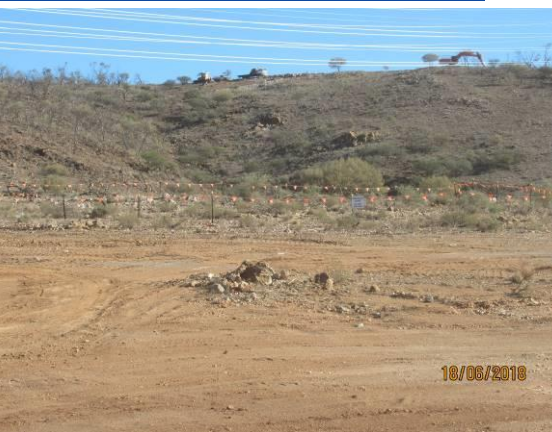
Photo 11.	Demarcation of aboriginal sites in the vicinity of the substation using flagged rope. CATCON reported that when construction was completed around these areas the flagging had been removed. As construction in this area was ongoing, the flagging was still in place.

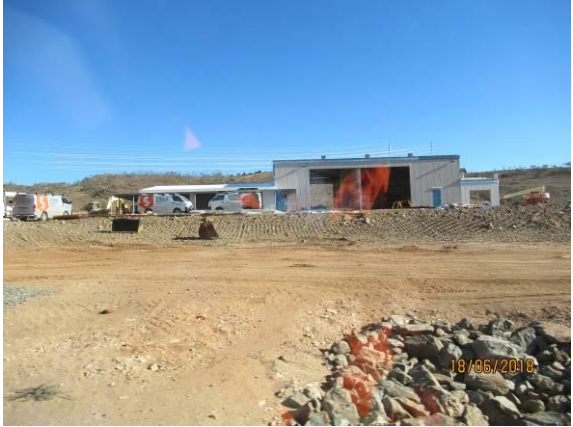
Photo #	Comment	Photo
Photo 12.	Operations Building under construction.

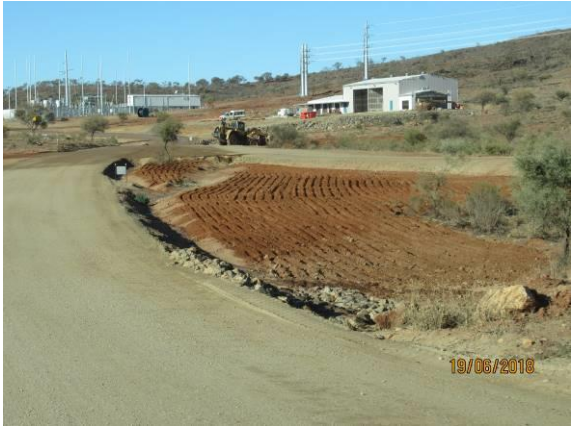
A photograph showing the Operations Building under construction. The building is a long, low structure with a corrugated metal roof. It is surrounded by a dirt area with some construction equipment and materials. A date stamp '18/06/2018' is visible in the bottom right corner.
Photo 13.	Rehabilitated areas near the Operations Building.

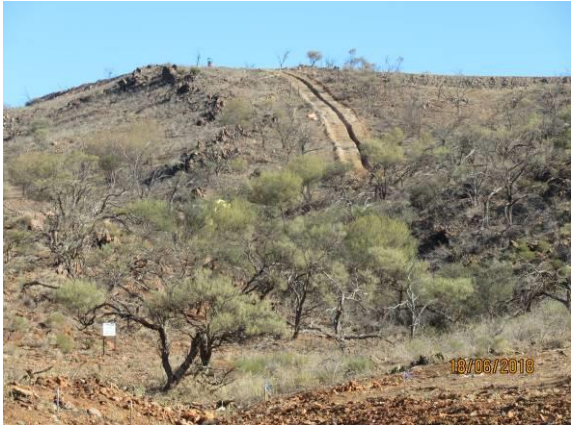
A photograph showing rehabilitated areas near the Operations Building. The area is a dirt road or path with a large, rectangular, reddish-brown area of soil that has been excavated or graded. The background shows the Operations Building and some trees. A date stamp '19/06/2018' is visible in the bottom right corner.
Photo 14.	Excavated and open trench running up the slope above the Substation.

A photograph showing an excavated and open trench running up the slope above the Substation. The trench is a deep, narrow cut in the earth, running diagonally across the frame. The surrounding area is covered with dry, scrubby vegetation. A date stamp '18/06/2018' is visible in the bottom right corner.

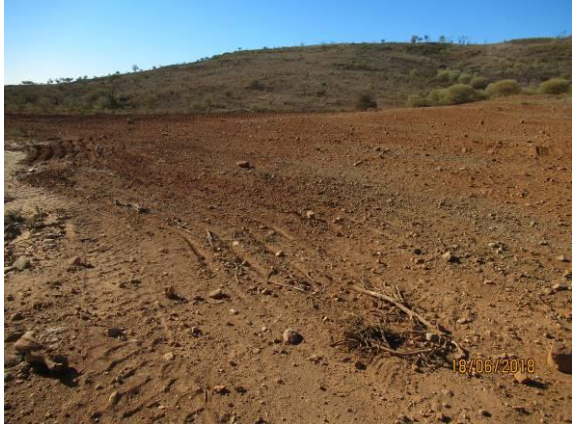
Photo #	Comment	Photo
Photo 16.	Former laydown area adjacent the substation rehabilitated by contouring and gentle rip across the contour.

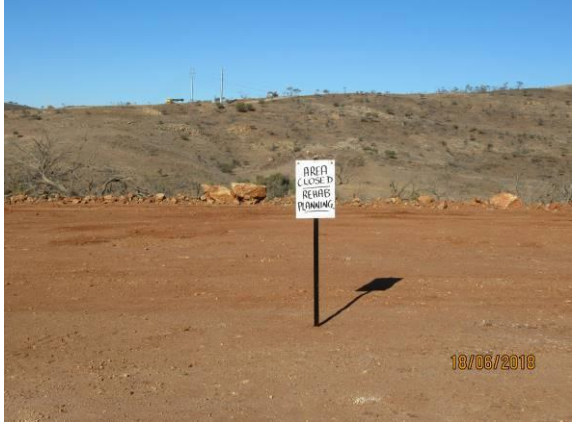
Photo 17.	Where areas were being prepared for rehabilitation, signs had been placed to avoid trafficking on these areas.

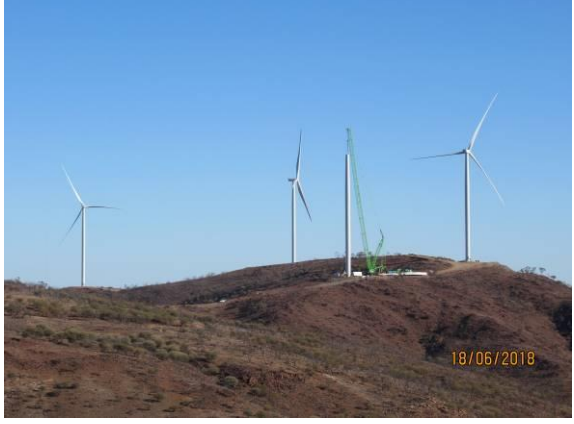
Photo 18.	Construction of turbines in Area 2, with crane at Turbine T53.

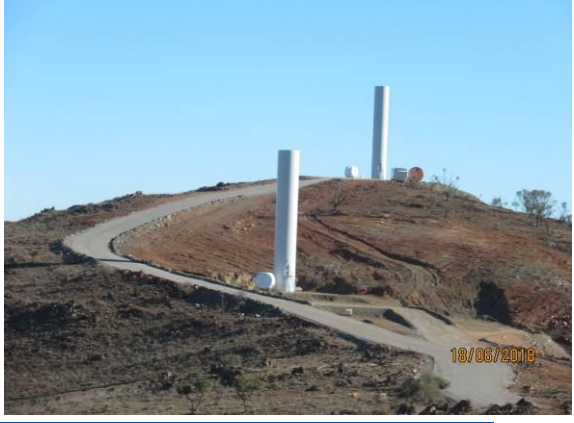
Photo 19.	Turbines T40 and T41 in Area 2. Note that cable trenches are on separate alignments to the access road which has increased the disturbed foot print. CATCON indicated this is required to enable the construction sequence to occur without impediment and delays.

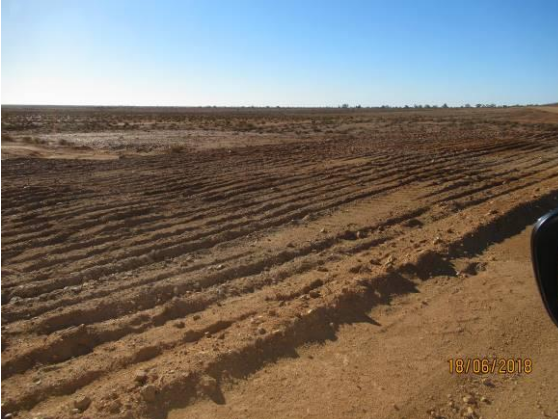
Photo #	Comment	Photo
Photo 20.	Disturbed areas along the access road between Area 2 and Area 7 on the western side of the Wind Farm. The areas have been lightly ripped across the contour.

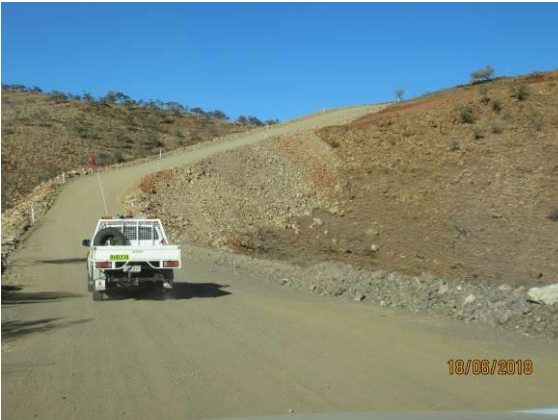
Photo 21.	Access road into Area 7 with Porcupine Grass Sparse Woodland Communities in the hill on the left of the photo.

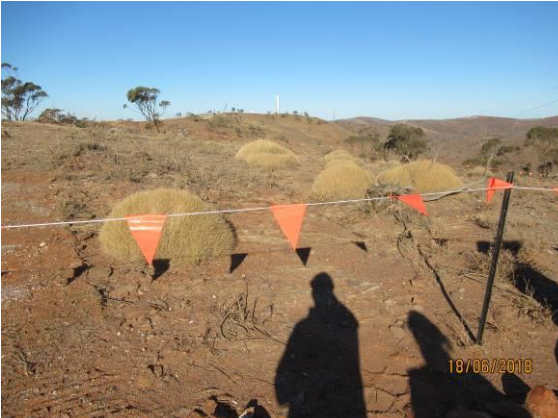
Photo 22.	Area 7 with Porcupine Grass Sparse Woodland Communities at T32. Flagging was observed delineating the cleared area from the Porcupine Grass Sparse Woodland Communities at this location.

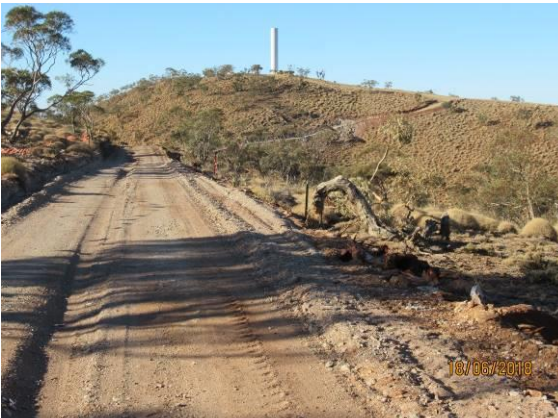
Photo 23.	Cable route from T34 to T32 cut into Porcupine Grass Sparse Woodland Communities. Flagging was observed along the access road created by the cable route. There were no erosion and sediment (ERSED) controls along the length of the access road which had a steep gradient in places. This had the potential to cause concentration of flows along the road in a rain event.

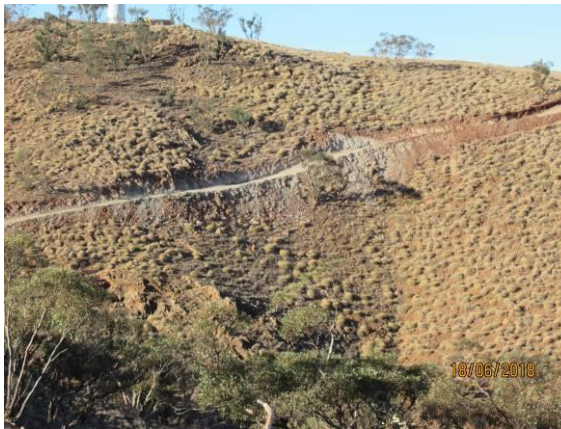
Photo #	Comment	Photo
Photo 24.	As above. Cut and fill for cable route between T34 and T32. Some road construction material had fallen down the slope in some areas.

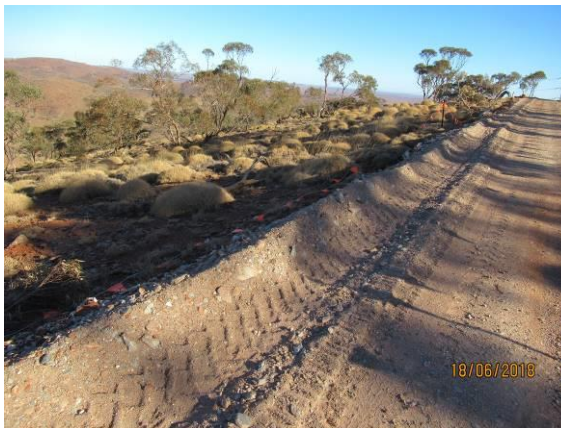
Photo 25.	Cable route between T34 and T32 with flagging fallen onto the ground. In this section there was very little disturbance outside of the footprint of the cable route. Post Inspection it was reported that this cable route would be re-contoured and rehabilitated rather than left as an access track.

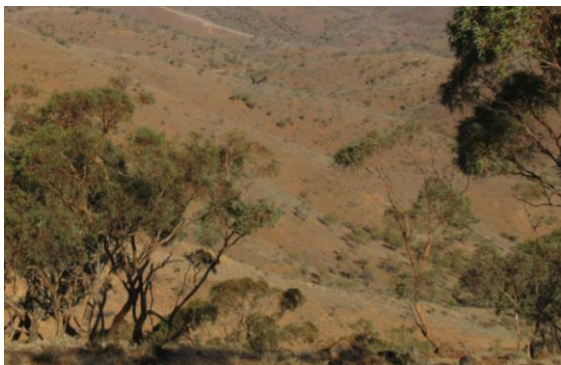
Photo 26.	A number of wedge tail eagles were observed in Area 7 including what appeared to be a mating pair. Some were observed landing on recently installed aerial transmission lines.

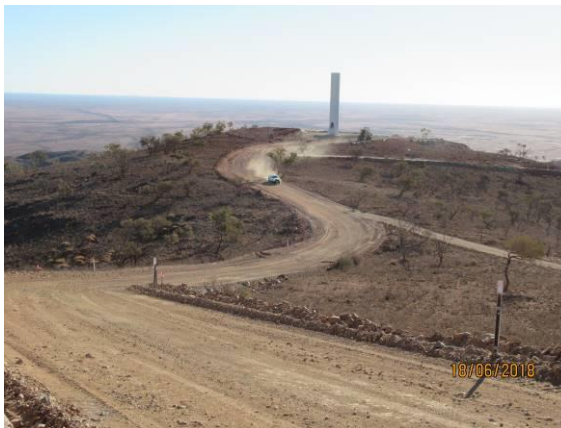
Photo 27.	View of T33 from T32. Some dust was observed to be generated from vehicles on roads, however it is considered impracticable to water all access roads particularly given severe water shortages in the area.

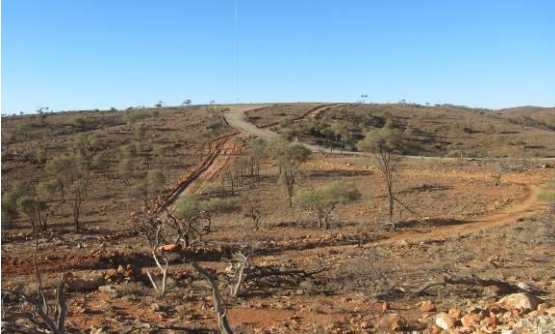
Photo #	Comment	Photo
Photo 28.	Cable line cut into ground separate to access road. It was reported that this is usual practice in wind farm construction. CATCON indicated that it was not possible from a logistics and timing perspective to install cables along the road access which would minimise the footprint of disturbance.

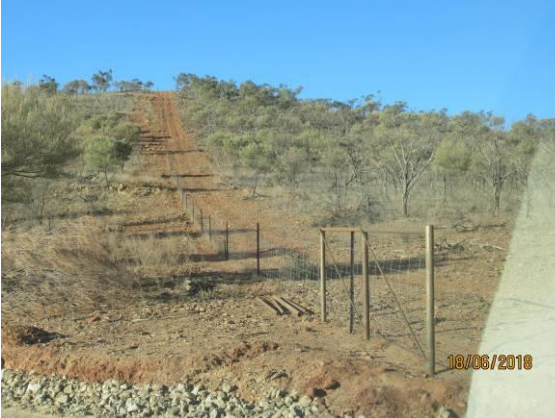
Photo 29.	A goat fence has been installed for a section of the site. Jacobs indicated this fence was installed under a grant separate to the Wind Farm project.

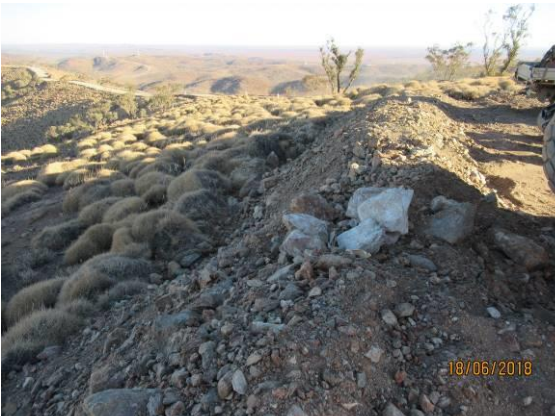
Photo 31.	Access road along a rocky ridge to T31 in Area 7 containing Porcupine Grass Sparse Woodland Communities. It was noted the disturbance footprint had been minimised along this section with very little disturbance noted outside the access road footprint.

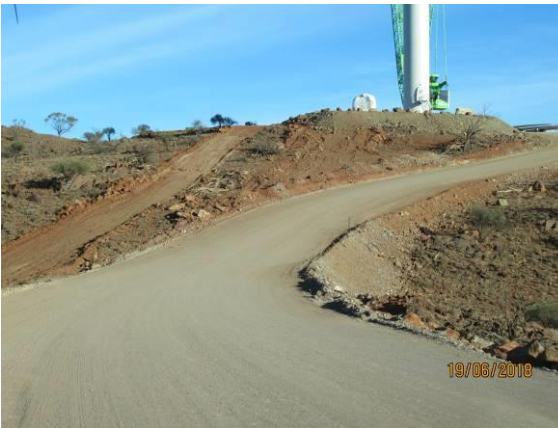
Photo #	Comment	Photo
Photo 36.	<p>Access Road and cable run to T53 in relatively steep areas. Limited proactive drainage measures were observed on the road or the cable run.</p> <p>CATCON indicated that measures would be installed if rain was forecast. The cable run was yet to be rehabilitated</p>

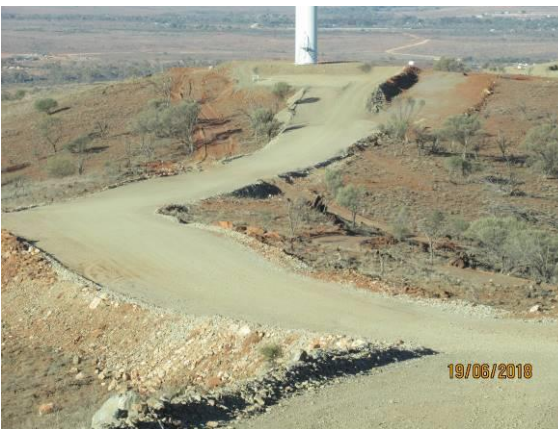
Photo 37.	<p>Typical tower set up with large footprint required for crane pads and blade storage (for all three blades) prior to lifting in place. Additional disturbance due to roads and cable runs. Towers located on steeper ground required additional areas for batter slopes.</p>

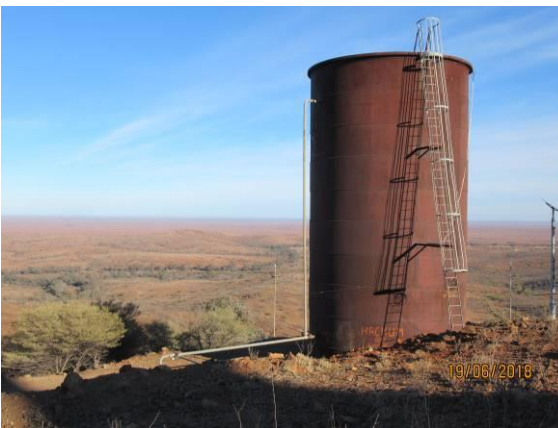
Photo 38.	<p>Heritage site SU53/HS1 (the Blue Anchor Tank) requiring protection under Condition 20 (Schedule 3) of the Project Approval. There was no observed impact to the item and it was some distance from work areas.</p>

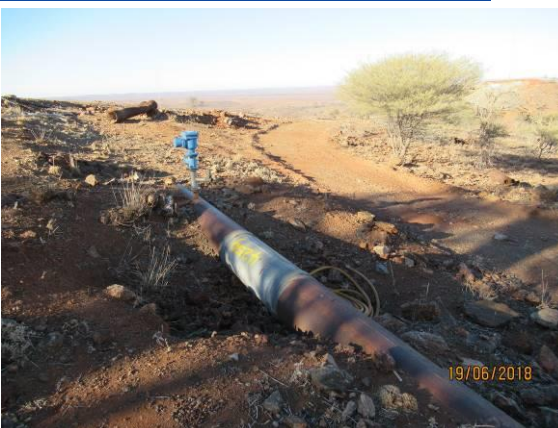
Photo 39.	<p>Water supply pipeline to Broken Hill. No impact to the pipeline was observed from CATCON works at this location.</p>

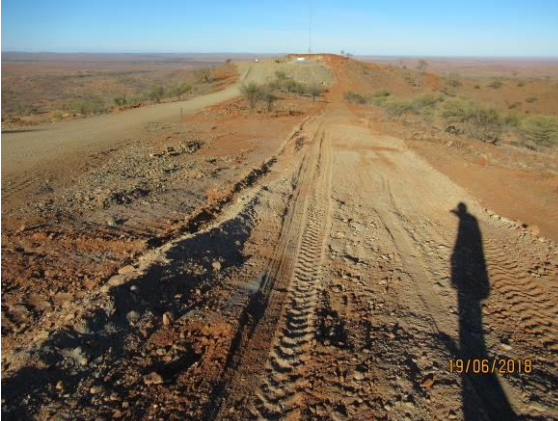
Photo #	Comment	Photo
Photo 40.	Looking towards T58, the closest turbine to Silverton. Cable run on the right and access road to the left.

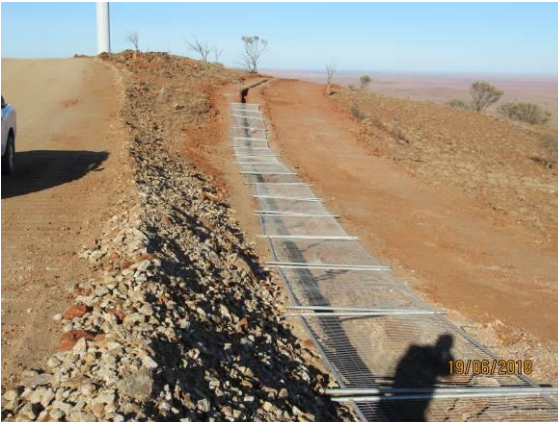
Photo 41.	Open trench covered with ATF fencing. This trench appeared to be open more than just overnight.

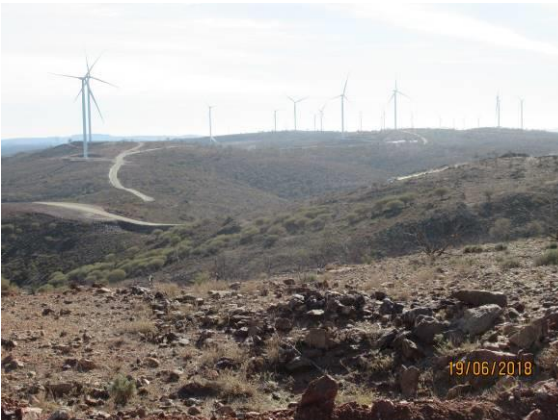
Photo 42.	There were a number of laydown areas and materials handling areas across the site. These will all require rehabilitation post construction.	 
Photo 43.	Looking north towards Areas 4 and 5.

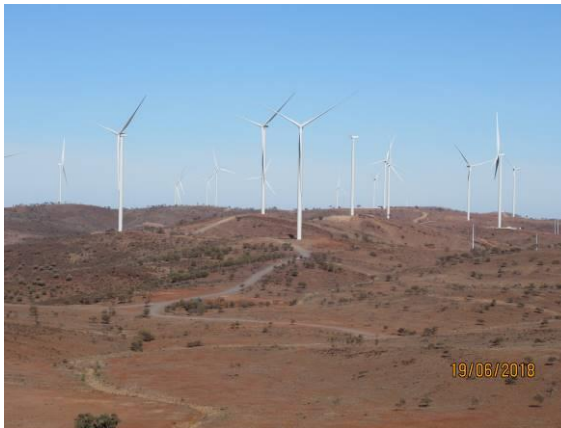
Photo #	Comment	Photo
Photo 52.	Looking south across Area 4 and 5. The landform is less steep than other areas of the wind farm such as Area 7.

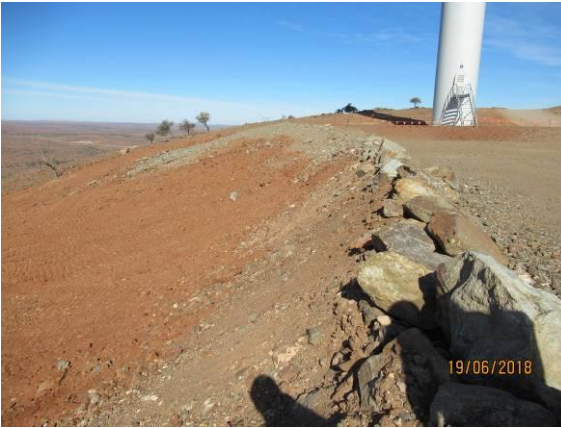
Photo #	Comment	Photo
Photo 56.	<p>While most sites were still under construction, the area around T50 was reported to have been rehabilitated. The landform around the tower pad had been re-contoured. The crane pads were reported to remain as is for future maintenance purposes.</p> <p>It was not able to be determined from the site inspection if topsoils/surface cover had been kept and were re-spread over the areas to promote rehabilitation from the existing seed bank. This aspect of topsoil separation was discussed verbally onsite with GE CATCON's environmental representative (Richard Sharpe) who reported that it occurred during his review of clearing practices.</p>

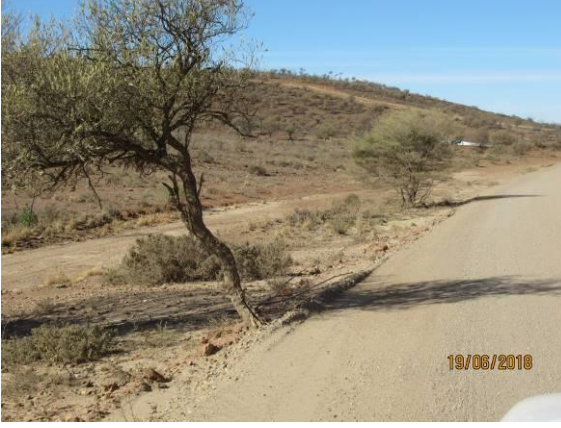
Photo 57.	<p>The main access road into the site crossed a drainage line/creek with no apparent culvert or pipe for the creek to flow in. Post the inspection, CATCON's designers indicated that the designed causeway was still to be constructed in this area. Given the large size of the catchment to this area, any significant rain event in the current state has a potential to wash out the access road.</p>

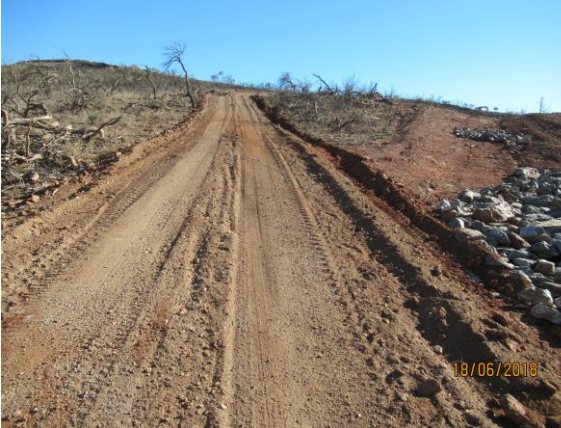
Photo 58.	<p>Cable run above the substation. No visual evidence of salvaging the top layer of soil containing the seedbank (e.g. wind row or stockpile of topsoils) was evident at this location.</p> <p>This aspect of topsoil separation was discussed verbally onsite with GE CATCON's environmental representative (Richard Sharpe) who reported that it occurred during his review of clearing practices.</p>

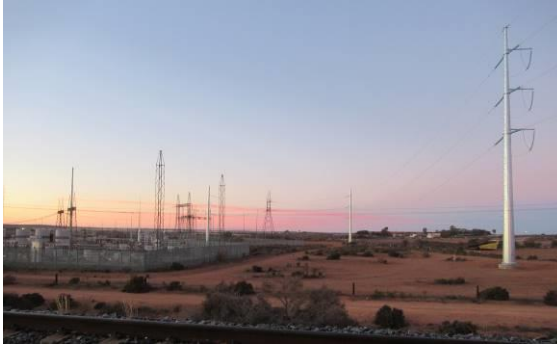
Photo #	Comment	Photo
Photo 59.	Substation at Broken Hill with transmission line crossing the Broken Hill railway line. Construction works on the transmission line had been completed prior to the audit.

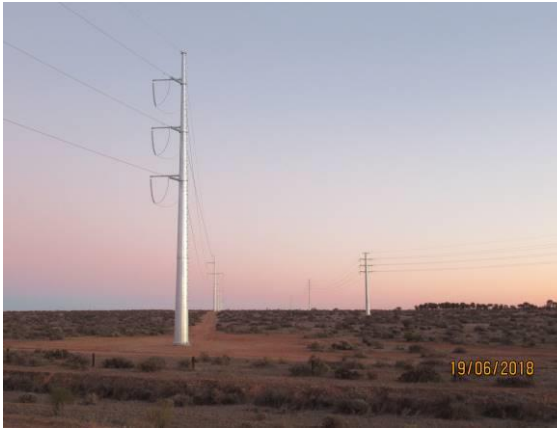
Photo 60.	Transmission line crossing the Broken Hill railway line (looking away from Broken Hill). The Broken Hill Solar Plant transmission line is on the right.

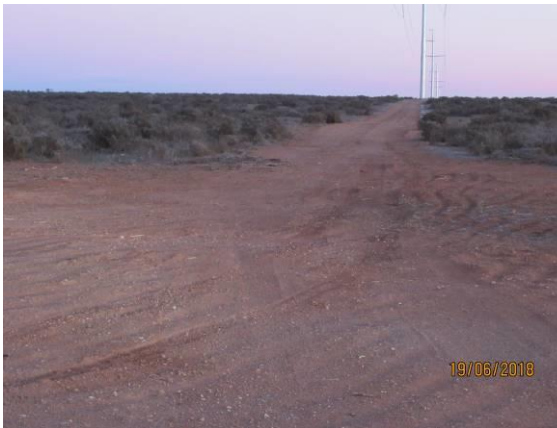
Photo 61.	Access track under transmission line near Pole 76. Jacobs stated disturbed areas have been rehabilitated by lightly ripping soils.

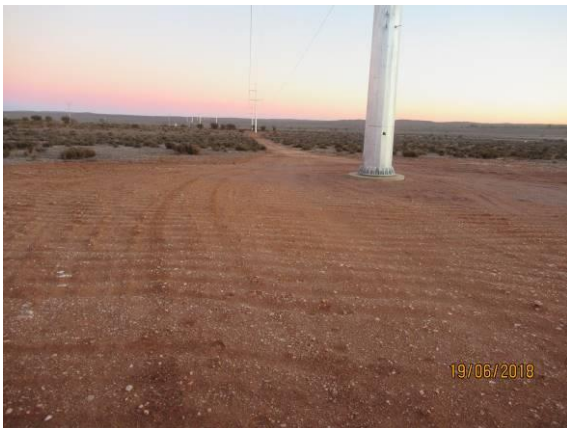
Photo 62.	Areas rehabilitated under the transmission lines were free of stockpiles and left in a neat condition. As above, soils were lightly ripped to provide a rough uncompact surface.

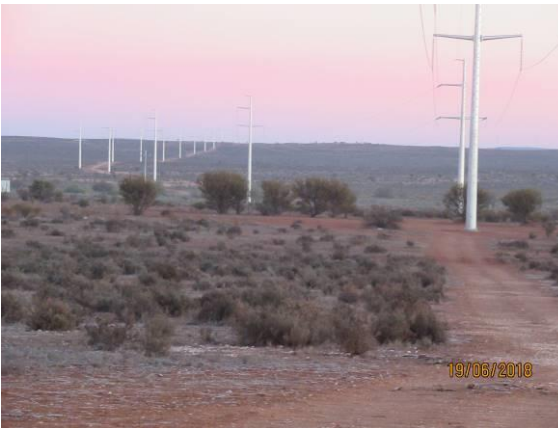
Photo #	Comment	Photo
Photo 63.	Transmission line crossing the Barrier Highway. An access track follows most of the transmission line route.

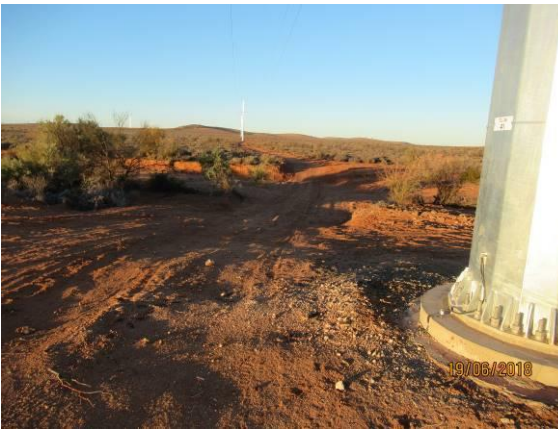
Photo 64.	Creek crossing at Pole 41.

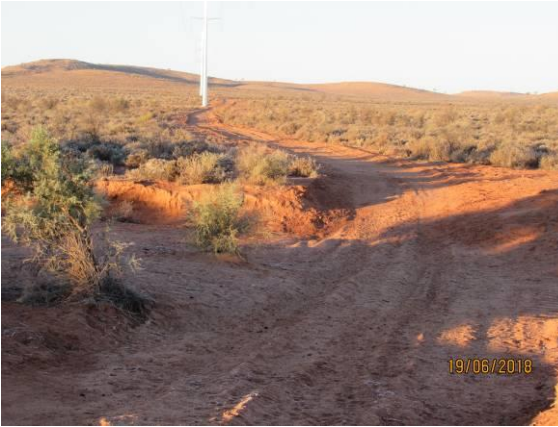
Photo 65.	<p>Creek crossing at Pole 41. It is understood that the creek was stabilised for vehicular access. There did not appear to be significant disturbance to the creek.</p> <p>However, it was observed that there was a long run along the access road to the creek without any diversions sending runoff water off the road. Given this, there is a potential for water to concentrate on the road leading to scouring on the road access to the crossing.</p>

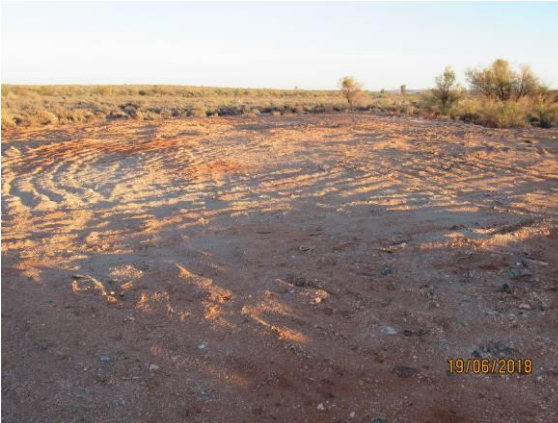
Photo 66.	There remains areas along the transmission line that have been rehabilitated, however with the very dry conditions no growth has been observed. It may take a long time for these areas to rehabilitate and will be weather dependent.

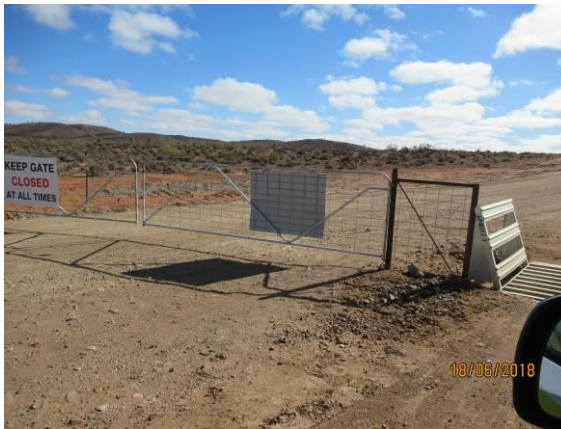
Photo #	Comment	Photo
Photo 74.	Intersection of site access road and Daydream Mine road.

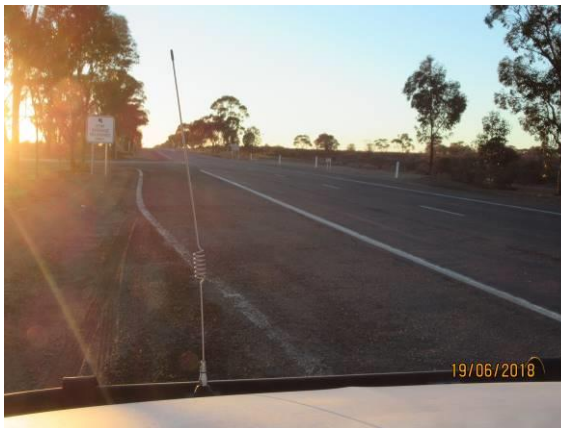
Photo 75.	Over dimensional turn off from Barrier Highway to Broken Hill Bypass.

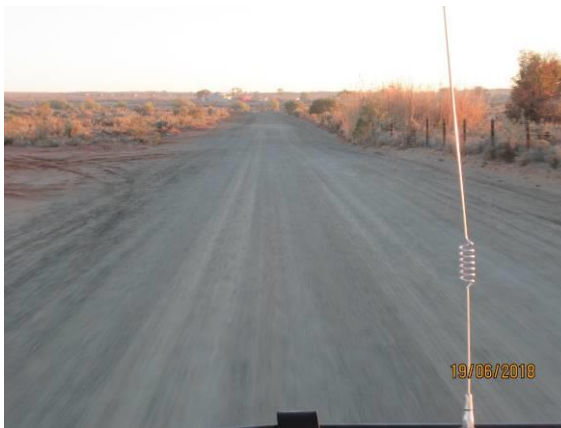
Photo 76.	Broken Hill Bypass road for over dimensional vehicles.
