# Silverton Wind Farm

Independent Environmental Audit – Action Response Plan

# SITE REHABILITATION PLAN

Project Name:	Silverton Wind Farm
Doc No.:	J880-PLN-040

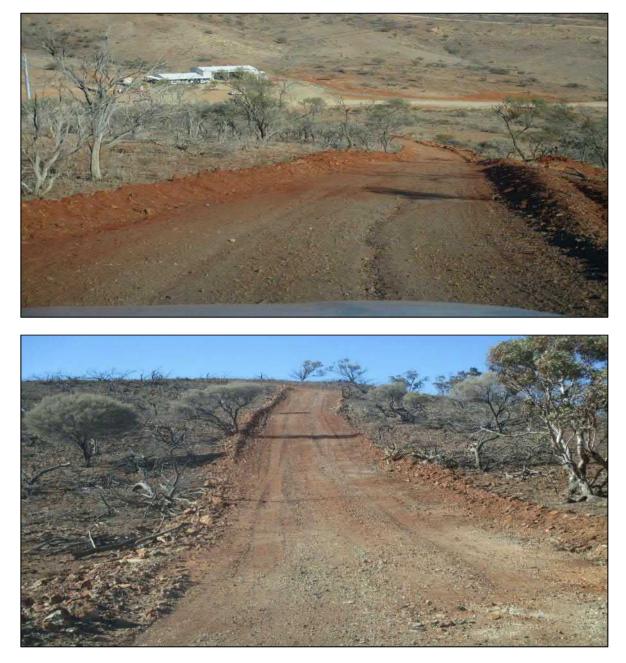
The photographs below are examples of HV transmission pole access tracks to be rehabilitated.

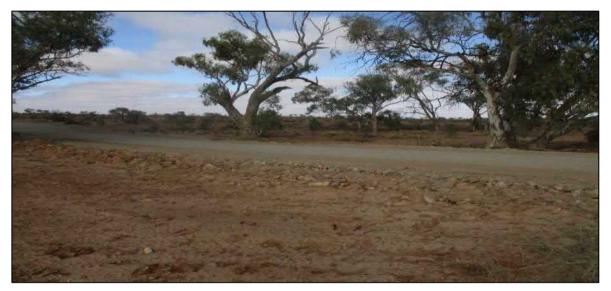
Photo: Lakes Creek Road crossing

- Rehabilitation works on the internal road network will involve the installation of erosion control structures etc. as per the approved Erosion and Sediment Control Plans;
- Creek crossings (Lakes Creek and Lakes Grave Creek) will have the road surface reinstated to level with creek bed so as not to obstruct flow and treated/topped with a stabiliser; and
- Additional works may be considered pursuant to a formal road report, if undertaken.

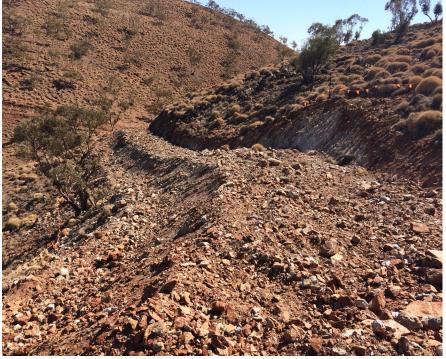
Rehabilitation attempts between T32 to T30 to be reviewed again with contractor if further reshaping can occur to a more natural profile. As disturbance is within the Porcupine Grass Sparse Woodland CEEC this is a highly sensitive location for importance of rehabilitations of native species.
