Latrobe Valley Regional Groundwater and Land Level Monitoring Report

Annual Report July 2020 to June 2021

Regional Monitoring Committee

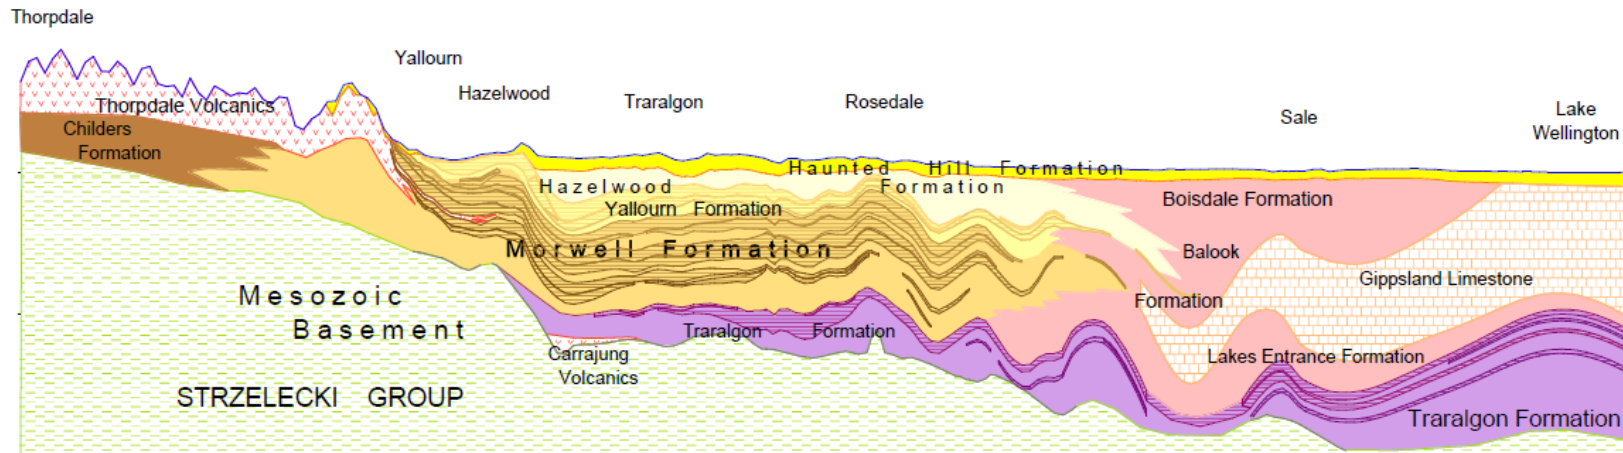
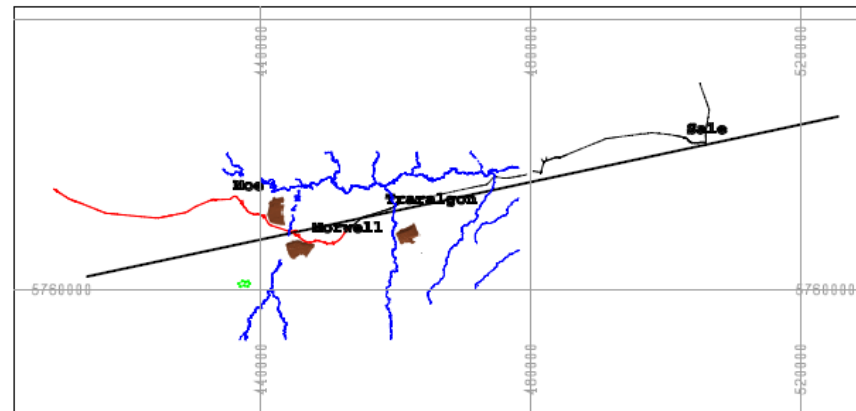
Figure 1 Onshore Gippsland Basin Regional Cross Section

Regional Hydrogeological Section Thorpdale to Lake Wellington

The mines operate within the Latrobe Valley Depression (LVD) that forms part of the larger Gippsland Basin. The LVD lies at the western end of the onshore part of the Basin. Three main lignite bearing sequences occur in the LVD, and are the Traralgon, Morwell and Yallourn Formations belonging to the Latrobe Valley Group (previously referred to as the Latrobe Valley Coal Measures). The Seaspray Group is a succession of marine limestones and marls that accumulated as a facies equivalent of the Latrobe Valley Group and extends over of the near coastal onshore and offshore parts of the Gippsland basin. A regional cross section (Figure 1) shows the Balook Formation, a transitional sand facies, forming the boundary between the mostly non-marine lignites and interseams to the west and the marine carbonates to the east. The Lower Cretaceous Strzelecki Group and Palaeozoic sediments form the basement to the younger Cenozoic sediments.
