Regional Monitoring Committee

Latrobe Valley Regional Groundwater and Land Level
Monitoring Report
Annual Report July 2018 to June 2019

December 2019

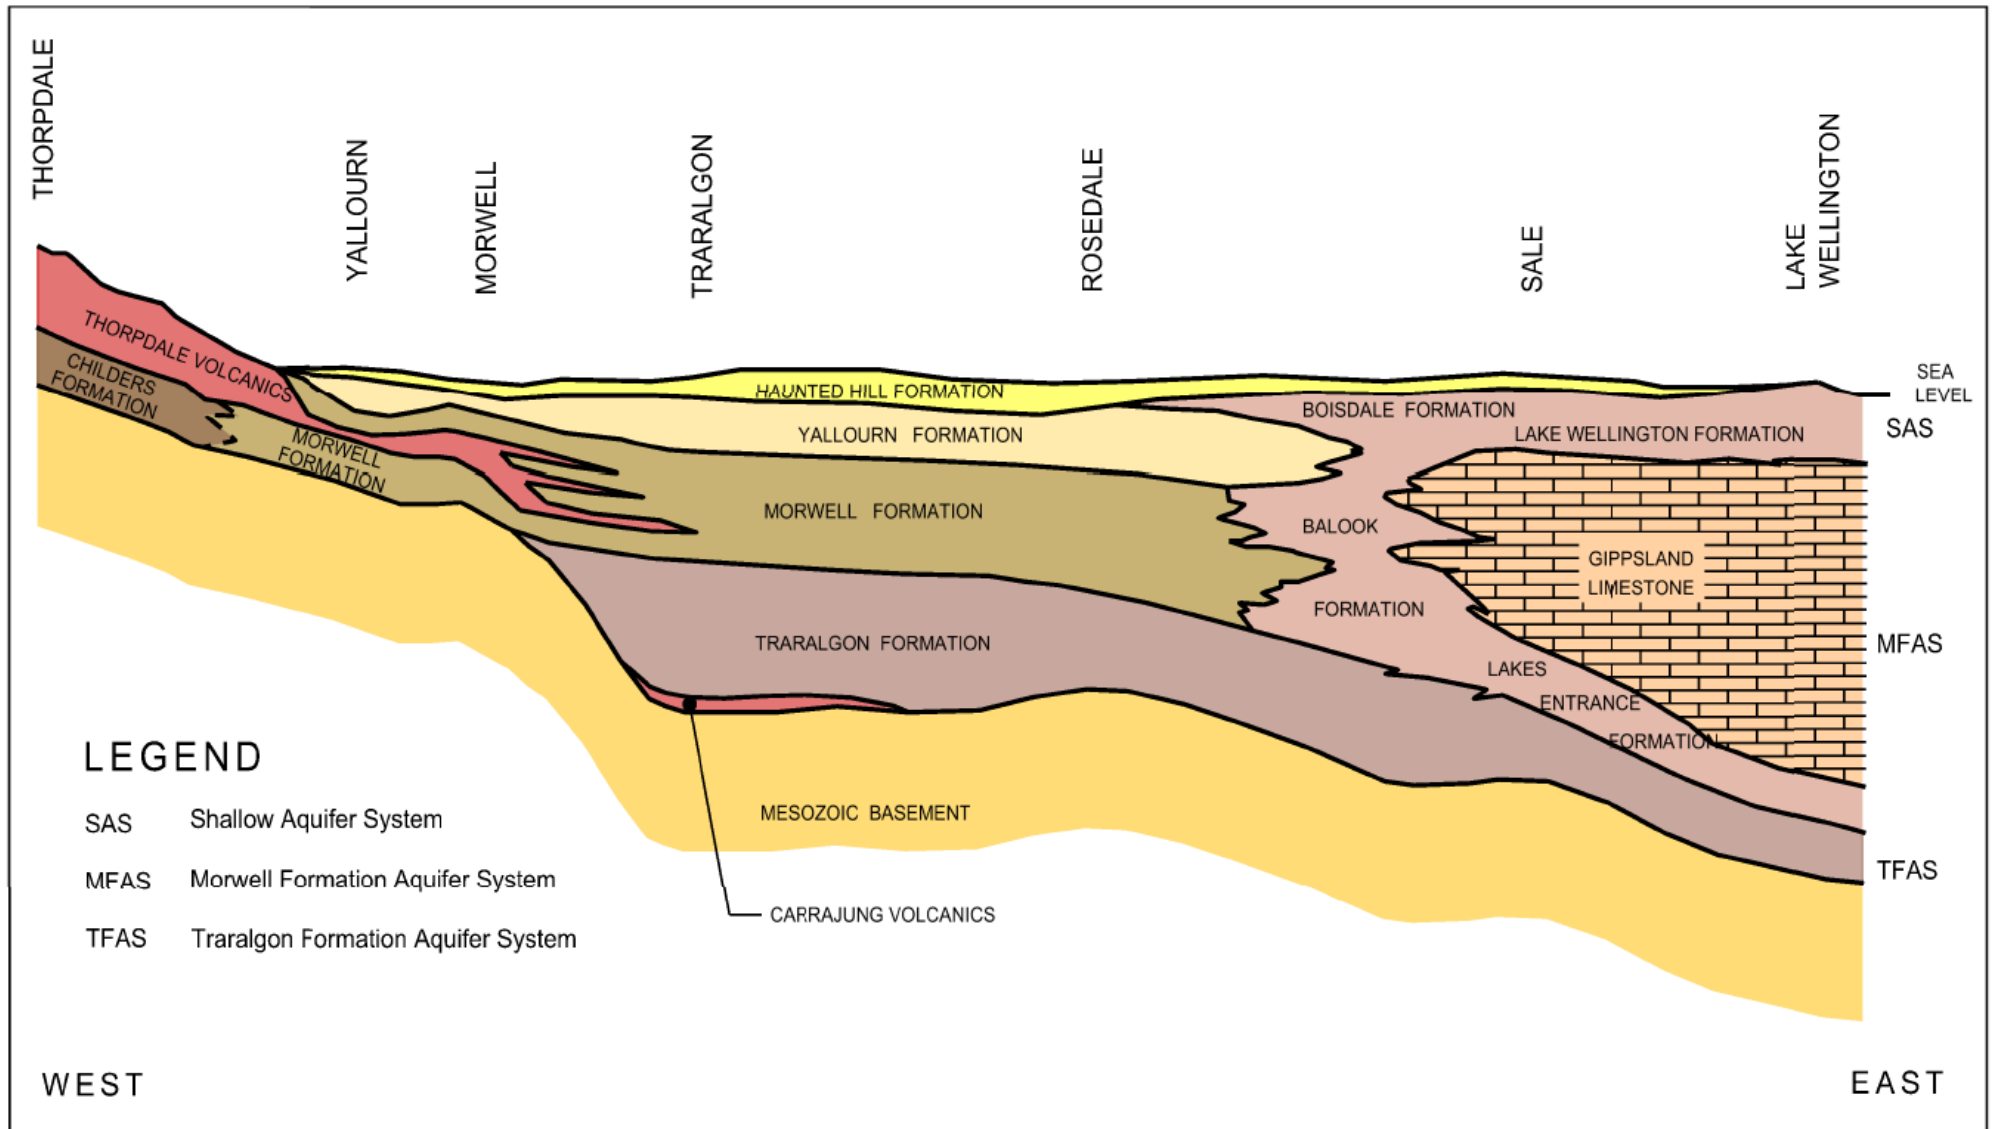
Figure 1 Onshore Gippsland Basin Schematic Section

The Latrobe Valley occurs at the western end of the onshore part of the Gippsland Basin. Three main lignite bearing sequences occur in the Latrobe Valley, and are the Traralgon, Morwell and Yallourn Formations. A succession of marine limestones and marls, accumulated as a facies equivalent to the Latrobe Valley coal measures, extends over of the near coastal onshore and offshore parts of the Gippsland basin. Figure 1 shows the transitional sand facies, and the Balook Formation, which forms the boundary between the mostly non-marine lignites and interseams to the west and marine carbonates to the east.

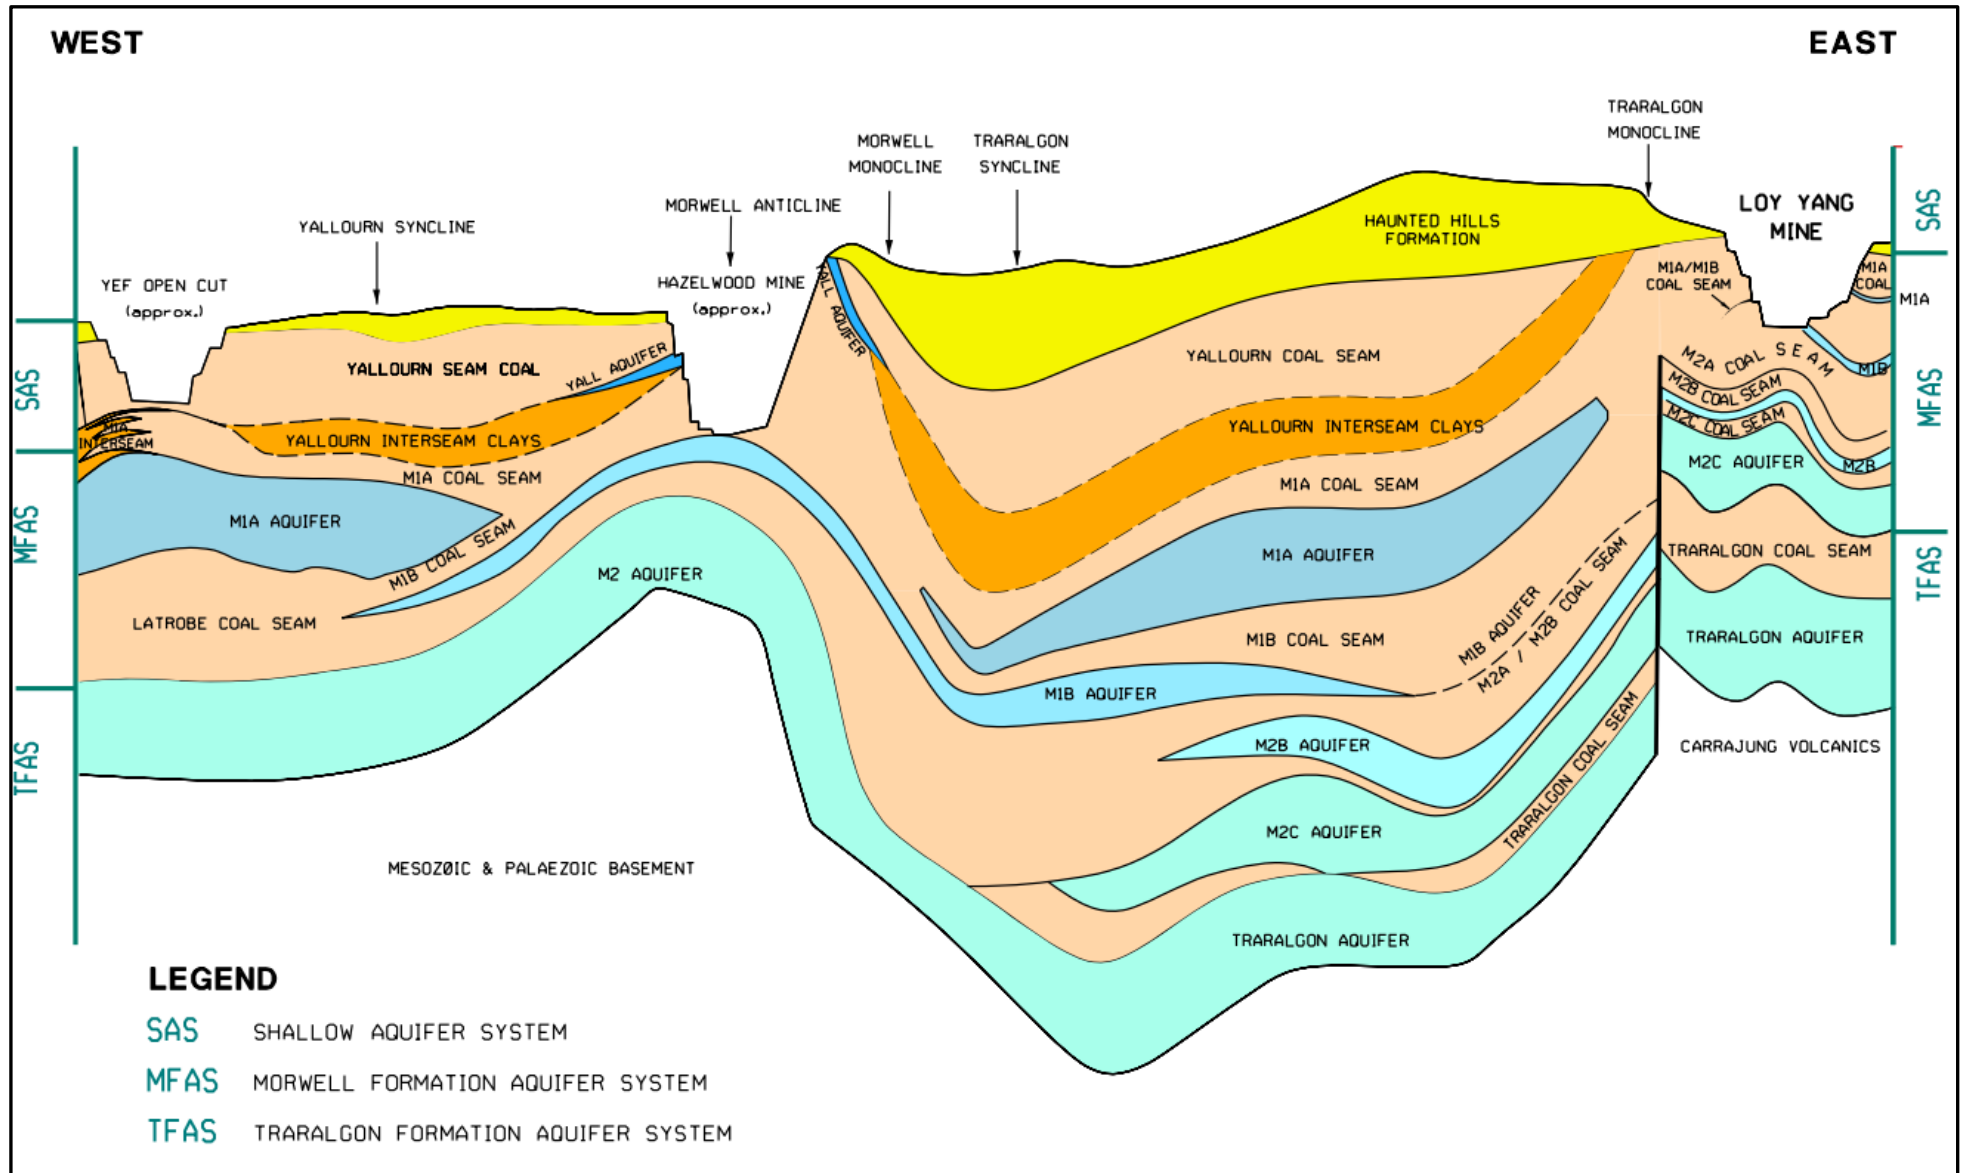
Figure 2 Yallourn East Field – Hazelwood – Loy Yang Schematic Hydrogeological Section

For the purpose of this report, three regional aquifer systems are defined. These aquifers represent the Shallow, Morwell Formation and Traralgon Formation Aquifer Systems in the western part of the Gippsland Basin. Figure 2 shows a schematic hydrogeological cross-section from the Yallourn East Field Mine through Hazelwood Mine and eastward to the Loy Yang Mine defining the major aquifers within the Latrobe Valley Mining area.
