AGL Macarthur

Bushfire Mitigation Plan 2023-2024

AGL Energy AEL Reference: ML MC FI 02 (Rev 5.2)

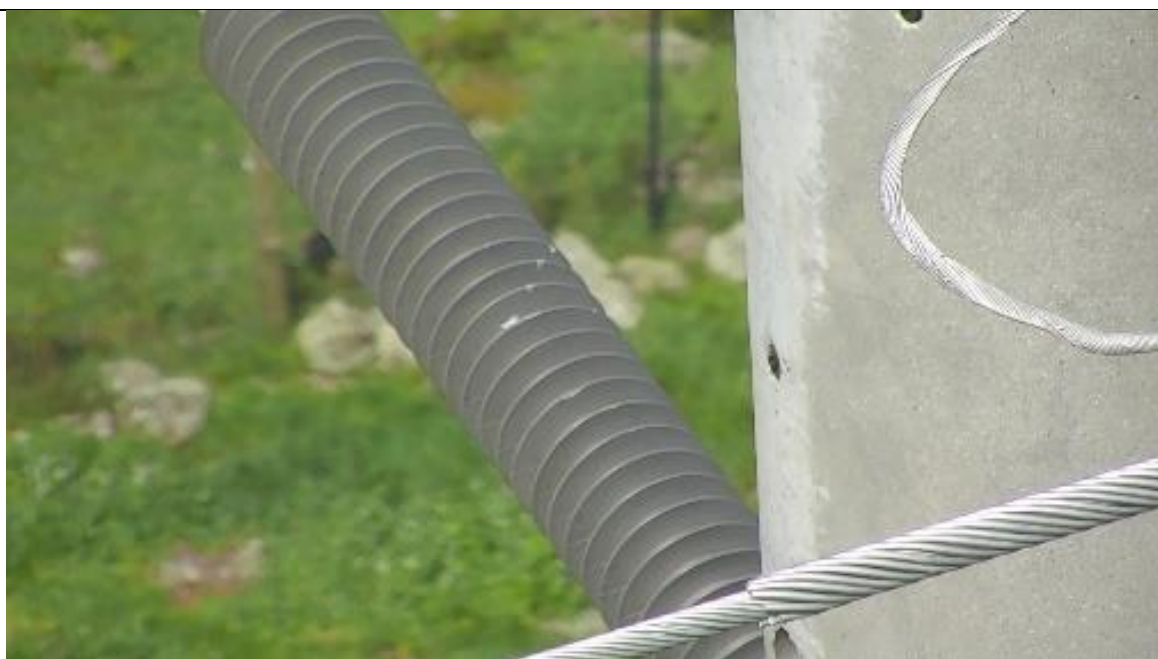
Damaged insulators (minor) picked up through inspections identified and captured in the replacement program (2020).

Since the initial construction of Macarthur wind farm in 2013, the only engineered solution relating to bushfire mitigation and overhead lines and easements has been the replacement of 132kV polymer line insulators damaged by fauna. An engineering design was completed on all 140 line insulators resulting in insulators being replaced with ceramic insulators in 2016 (18of), 2019 (16of) and 2023 (8of). Inspection programs have been ongoing to understand the condition of the insulators and AGL are preparing a replacement program that includes a further 9of priority polymer insulators.
