## **AGL Macarthur**

### **Bushfire Mitigation Plan 2025-2030**

AGL Energy AEL Reference: MWF-HS-PLN-006 (Rev 6.3)

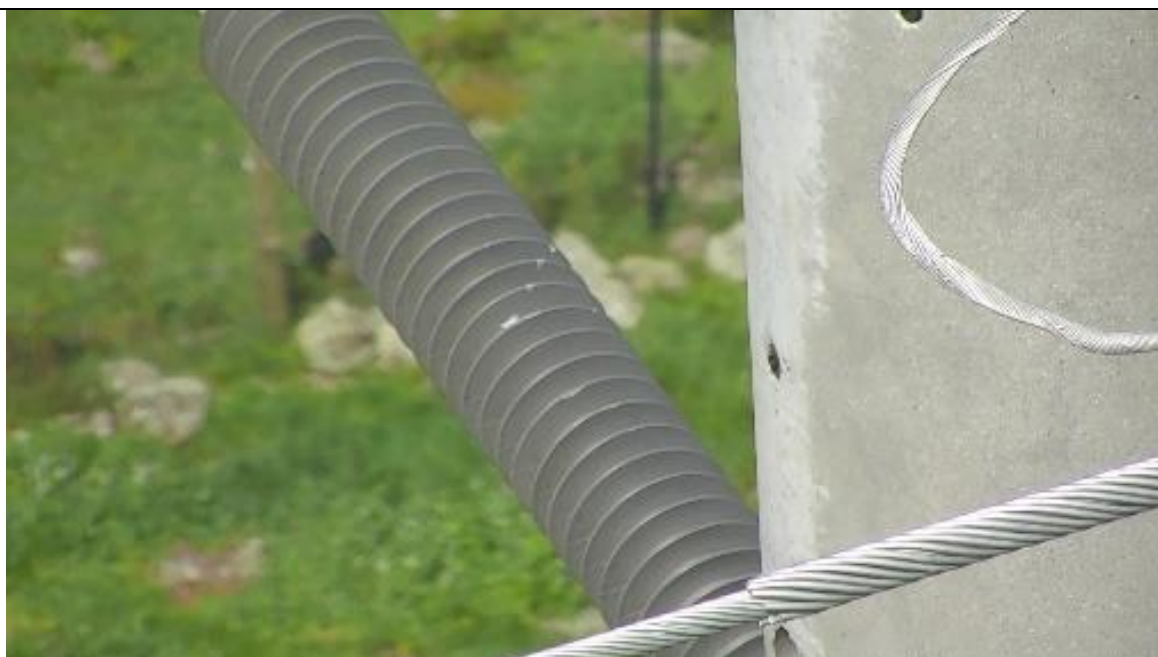
Damaged insulators (minor) picked up through inspections identified and captured in the replacement program (2020).

Since the initial construction of Macarthur wind farm in 2013, the only engineered solution relating to bushfire mitigation and overhead lines and easements has been the replacement of 132kV polymer line insulators damaged by fauna. An engineering design was completed on all 140 line insulators resulting in insulators being replaced with ceramic insulators in 2016 (18of), 2019 (16of) and 2023 (8of). Inspection programs have been ongoing to understand the condition of the insulators and AGL are preparing a replacement program that includes a further 9of priority polymer insulators.
