Health Safety & Environment Management System

# Ravensworth South Modification Rehabilitation Strategy

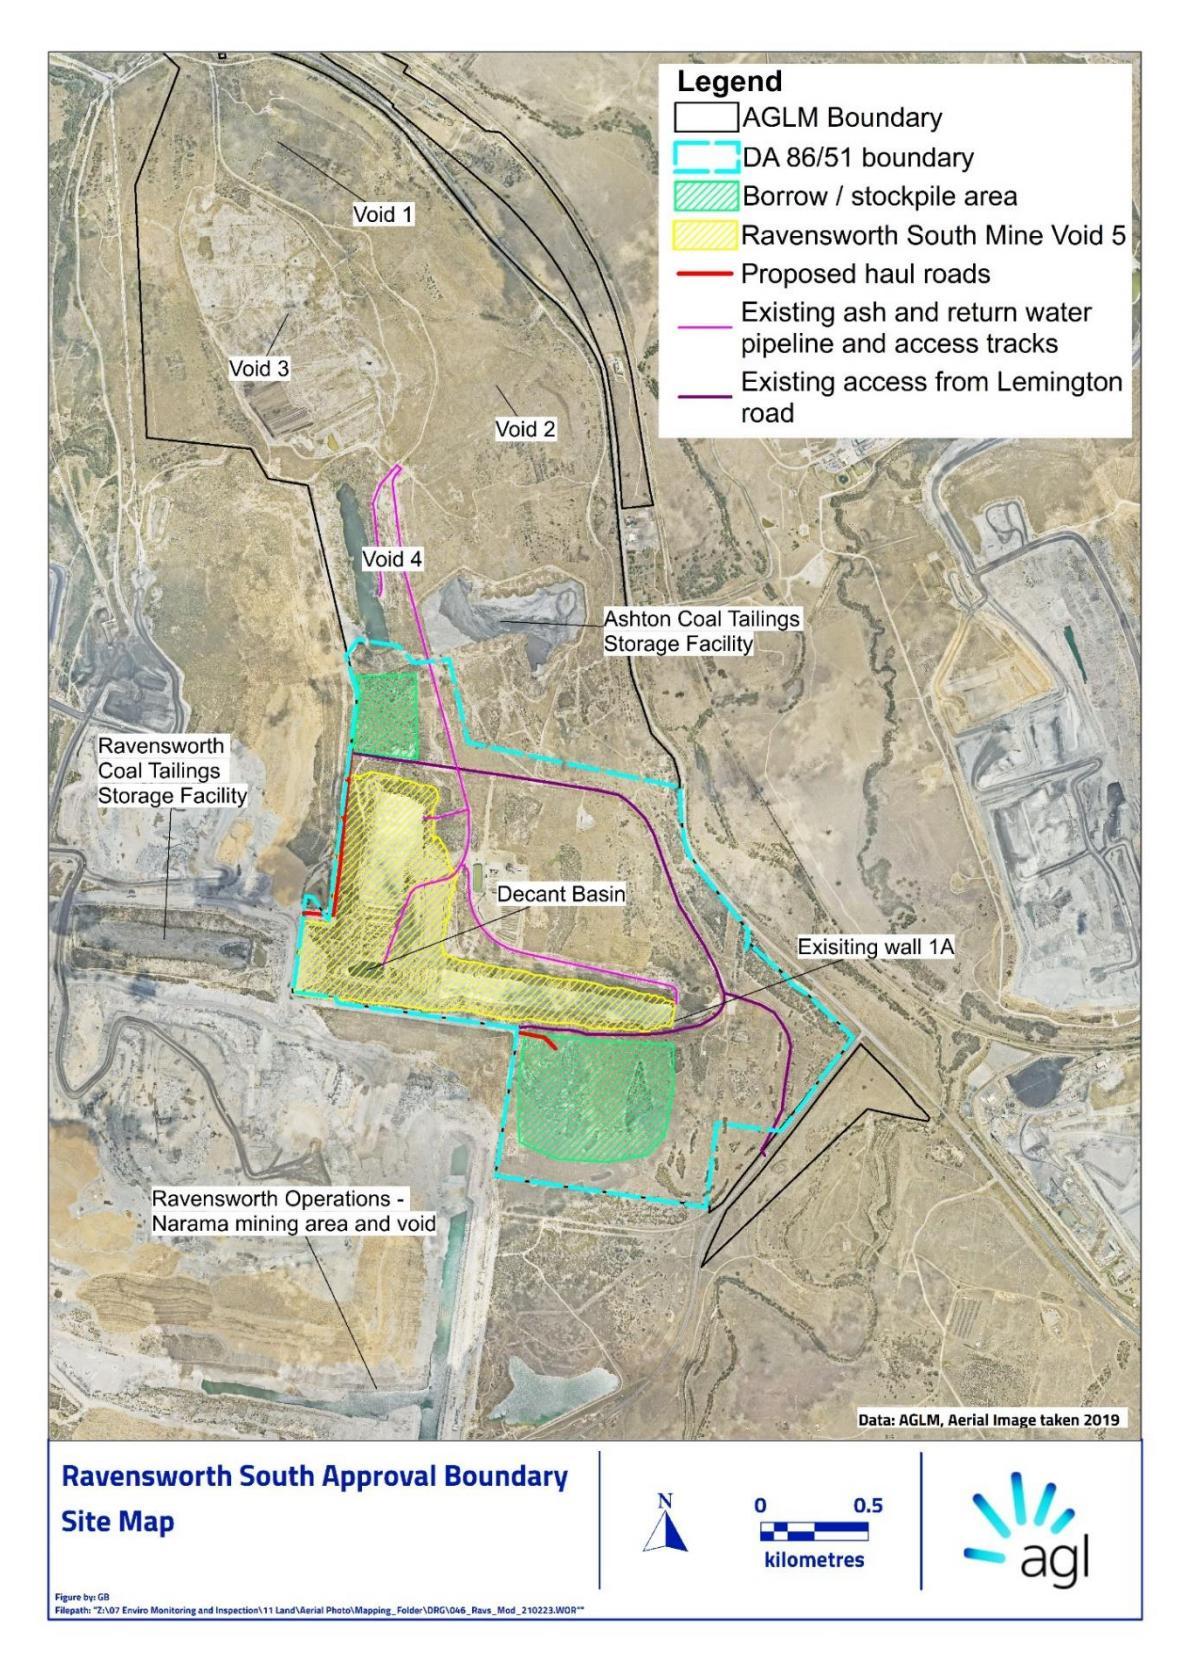
#### Figure 1.1 Ravensworth South

This Rehabilitation Strategy (Strategy) has been prepared specifically for the RSCM Void 5 project for AGLM. This Strategy also builds upon initial modification information provided within the Ravensworth South Mine – Rehabilitation Amendment Modification Report (Jacobs 2022a) and the Response to Submissions (Jacobs 2022b). An overview of the RSCM Void 5 project is shown in Figure 1.1.
