# AGL Camden Gas Project Hydraulic Fracturing Fact Sheet

**AGL has used hydraulic fracturing to increase gas production in Coal Seam Gas (CSG) wells in Camden.**

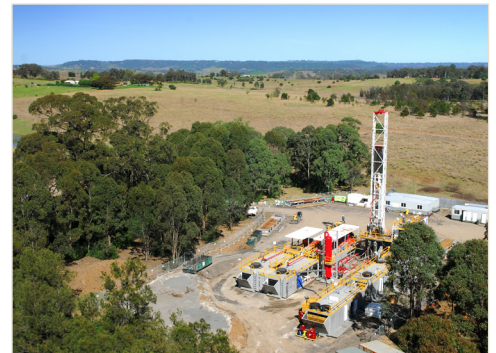
▲ Hydraulic fracturing in Camden.

The process involves injecting sand and fluids directly into the targeted coal seam. As the rate of injection increases, the pressure of the fluid creates stress in the coal seam until the coal fractures.

The addition of sand ensures that the pathway does not close. The fracture creates a pathway for gas and water to flow out of the coal seam to the wellbore allowing higher rates of gas production.

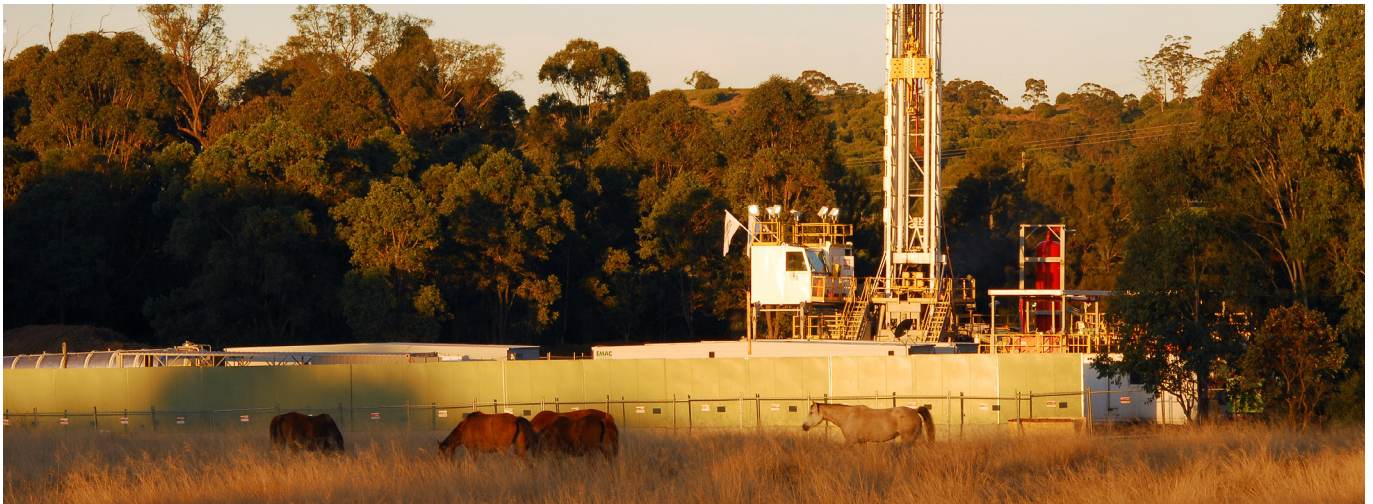
▲ Exploration pilot well within existing grazing land.
