Date 9 October 2014
To Nicola Fry
Copy Andrea Madden
From Carolina Sardella
Ref 2268518A-WAT-MEM-001 RevA
Subject Camden Gas Project - FY15 Q1 Monitoring Update - October 2014

This memo presents the updated hydrographs for the Denham Court, Menangle Park and Glenlee groundwater monitoring bores to August 2014 and the water quality results for the August 2014 sampling event. It also includes September 2014 water quality results for the Nepean River sample. Full analysis and discussion of these results will be presented in the comprehensive 2015 Annual Report which will detail all groundwater and quality results from the 2014/15 monitoring period.

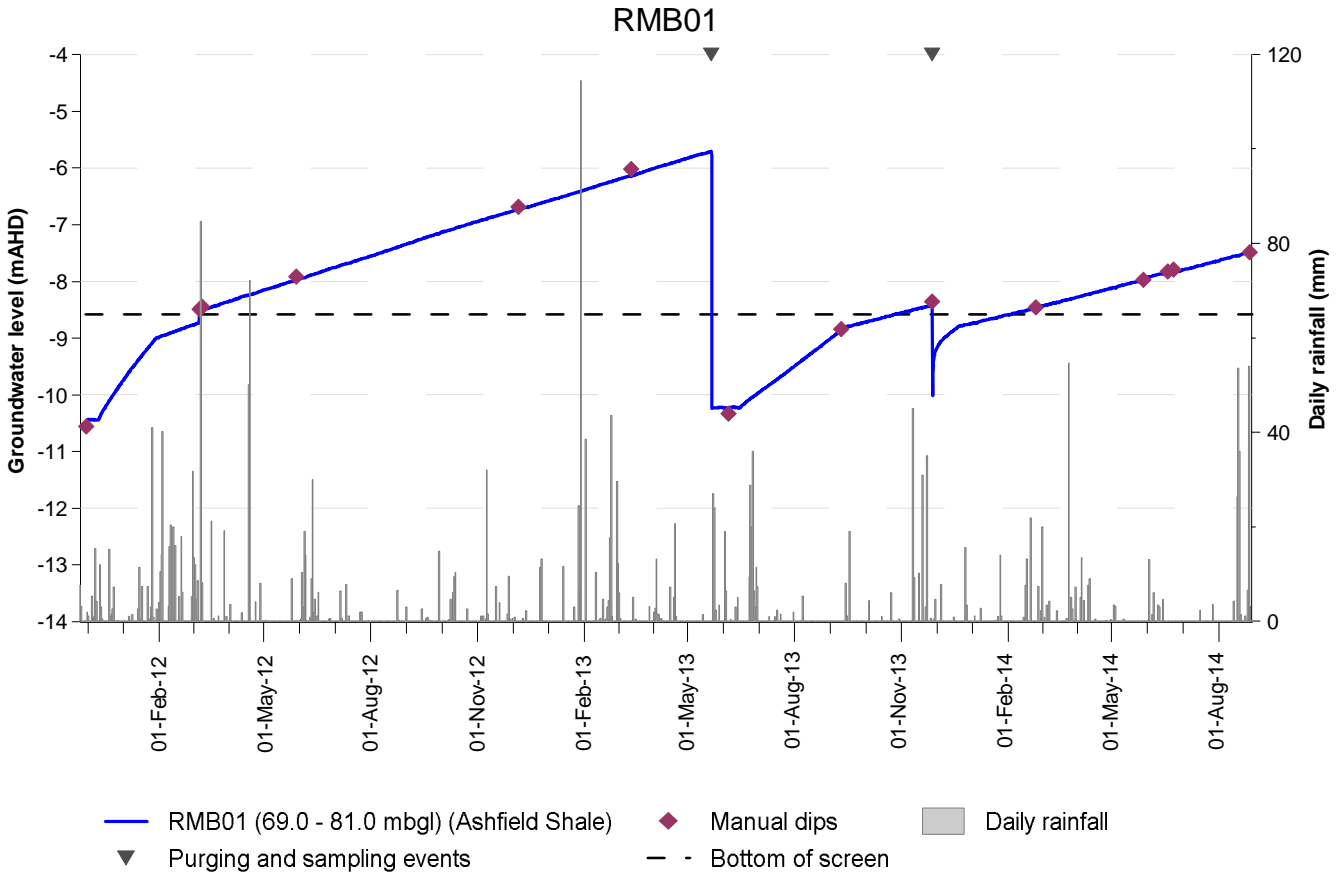
Figure A.1: RMB01 and RMB02 monitoring bores

Figures A.1 – A.2: Denham Court site hydrographs

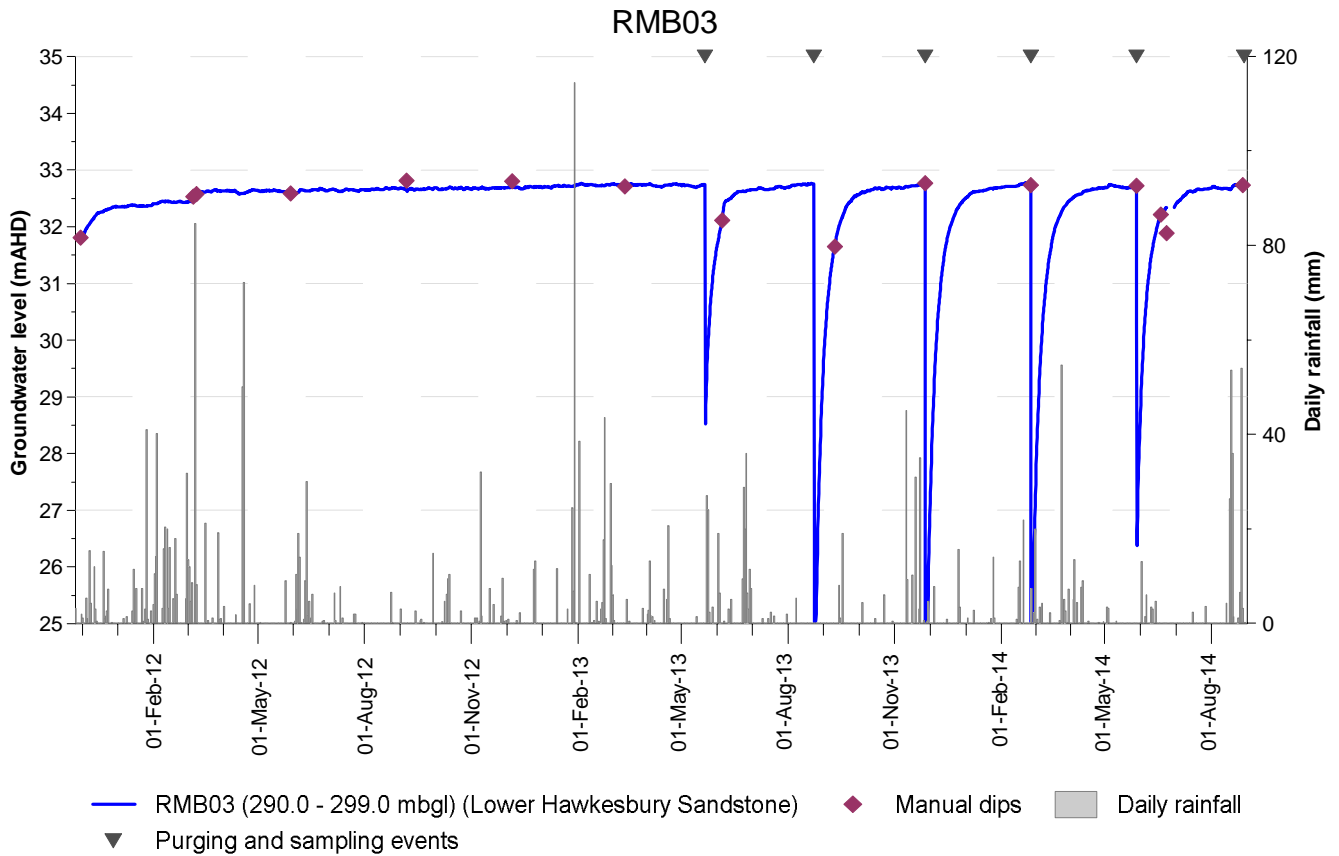
Figure A.2: RMB03 monitoring bore

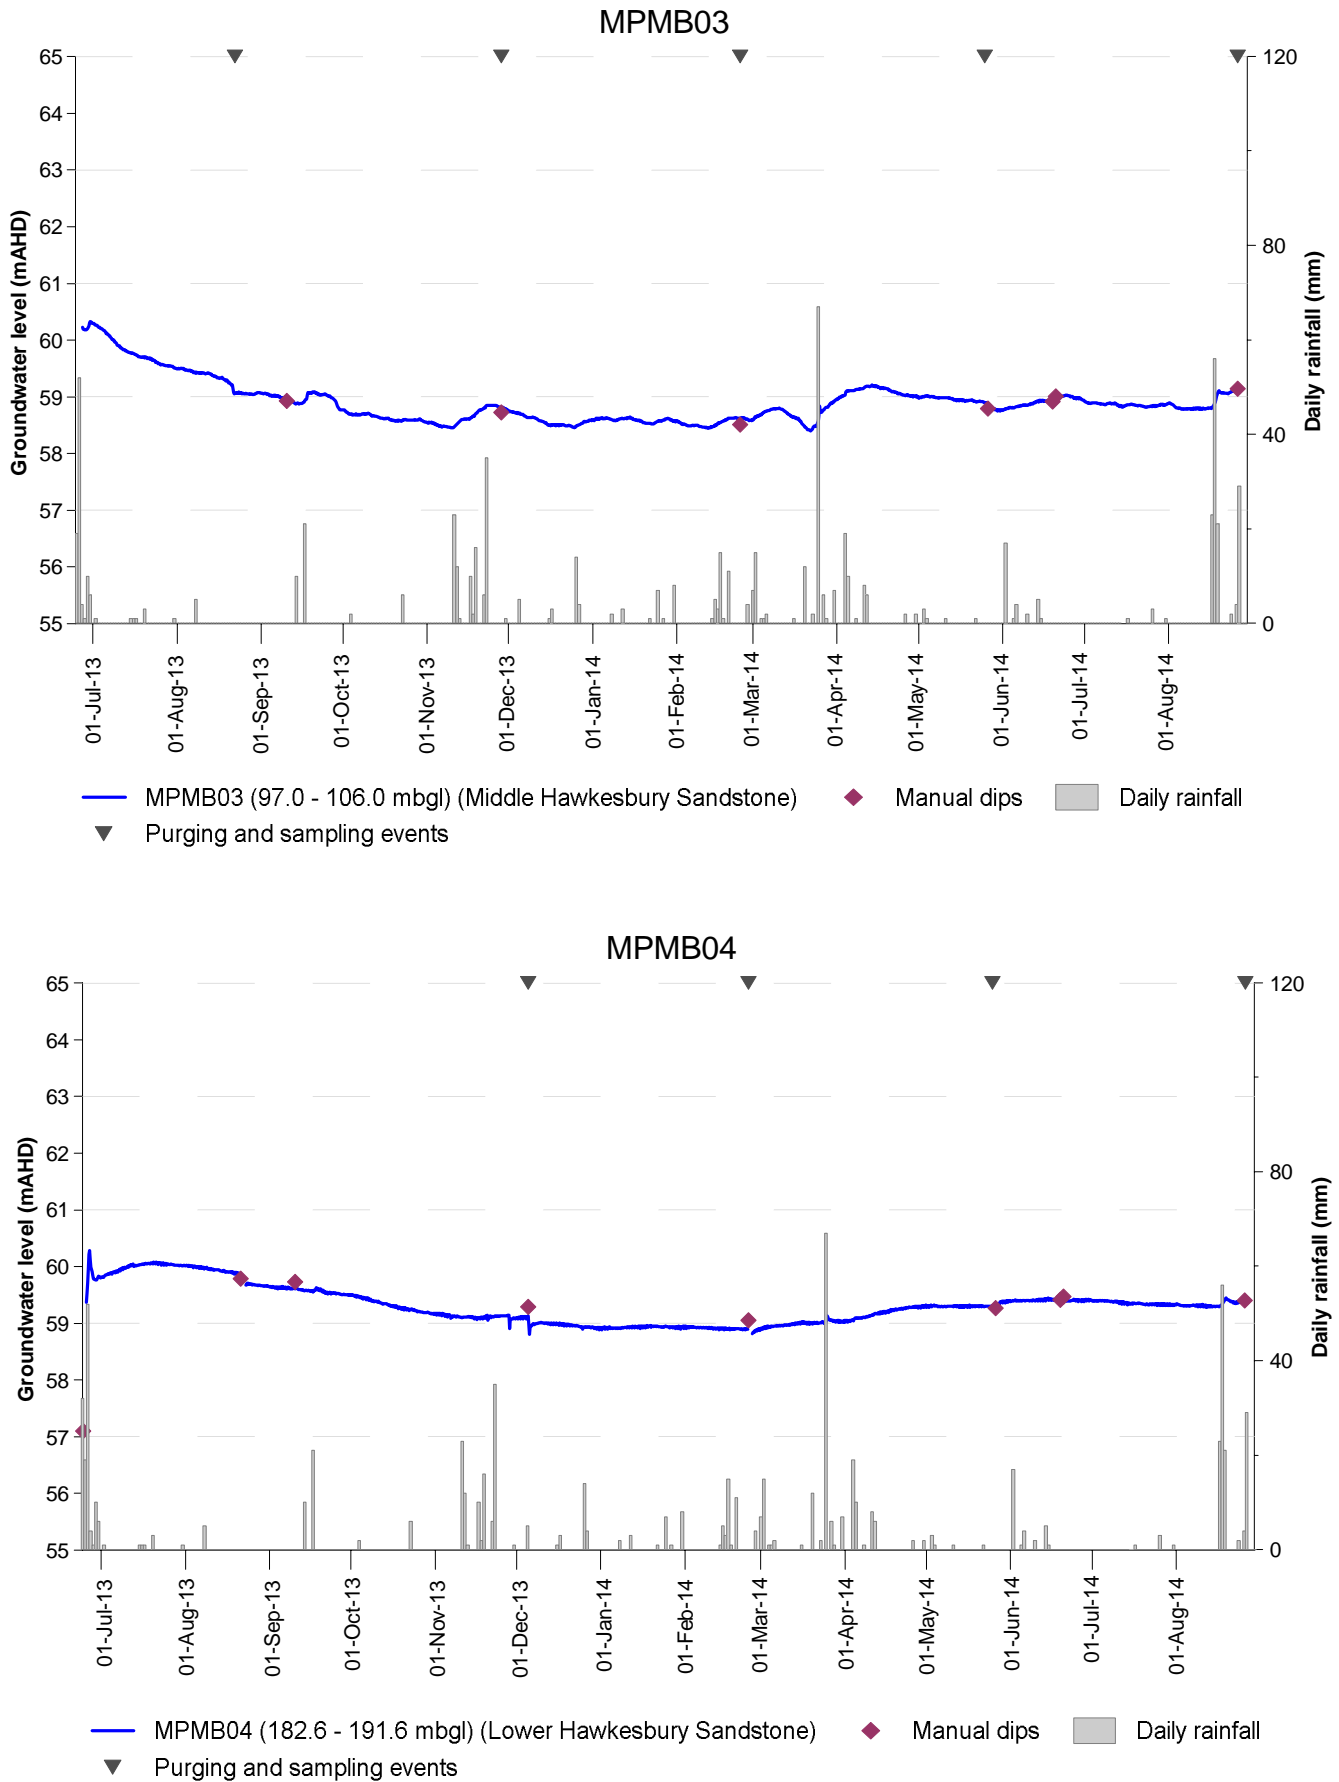
Figure A.4: MPMB03 and MPMB04 monitoring bores

Figures A.3 – A.4: Menangle Park site hydrographs

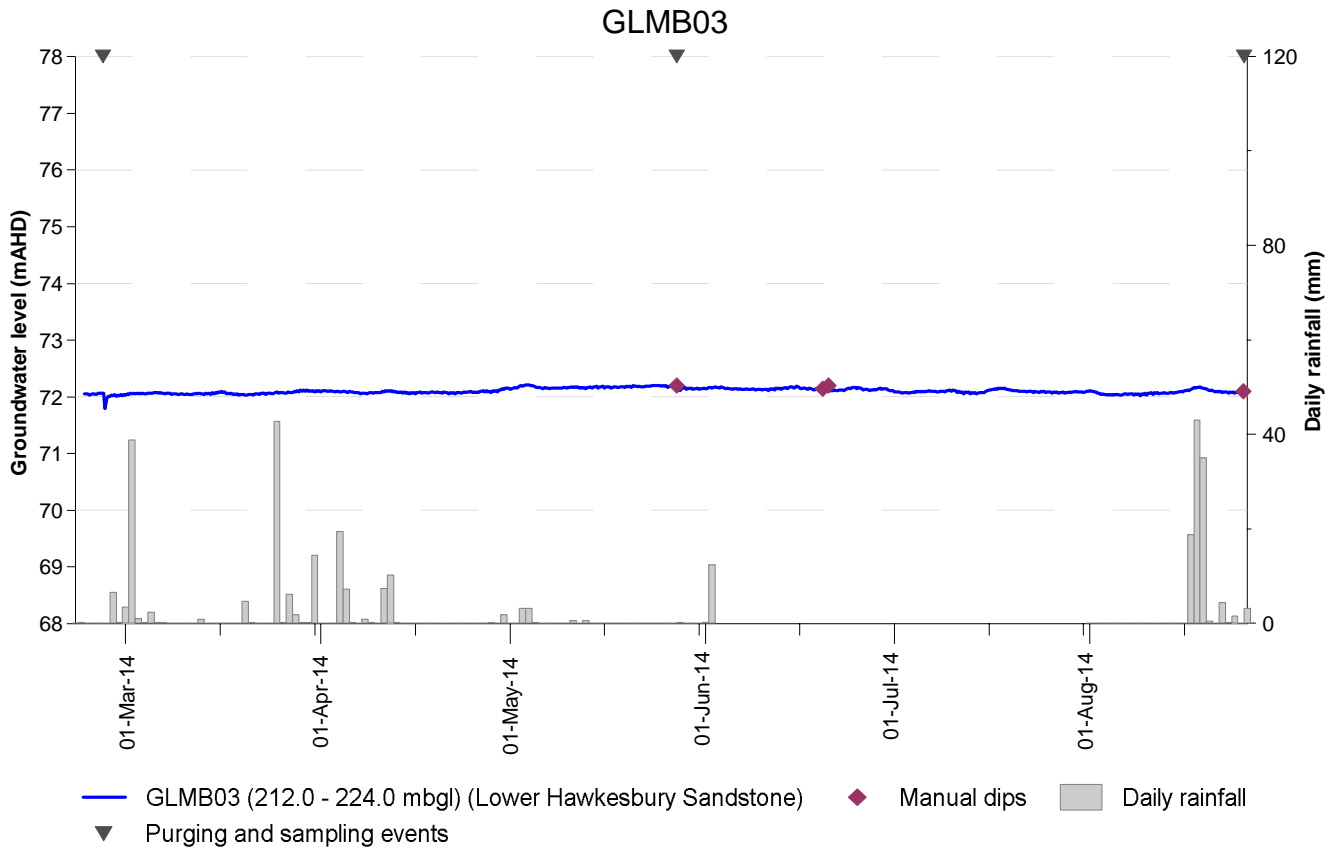
Figure A.6: GLM03 monitoring bore

Figures A.5 – A.6: Glenlee site hydrographs

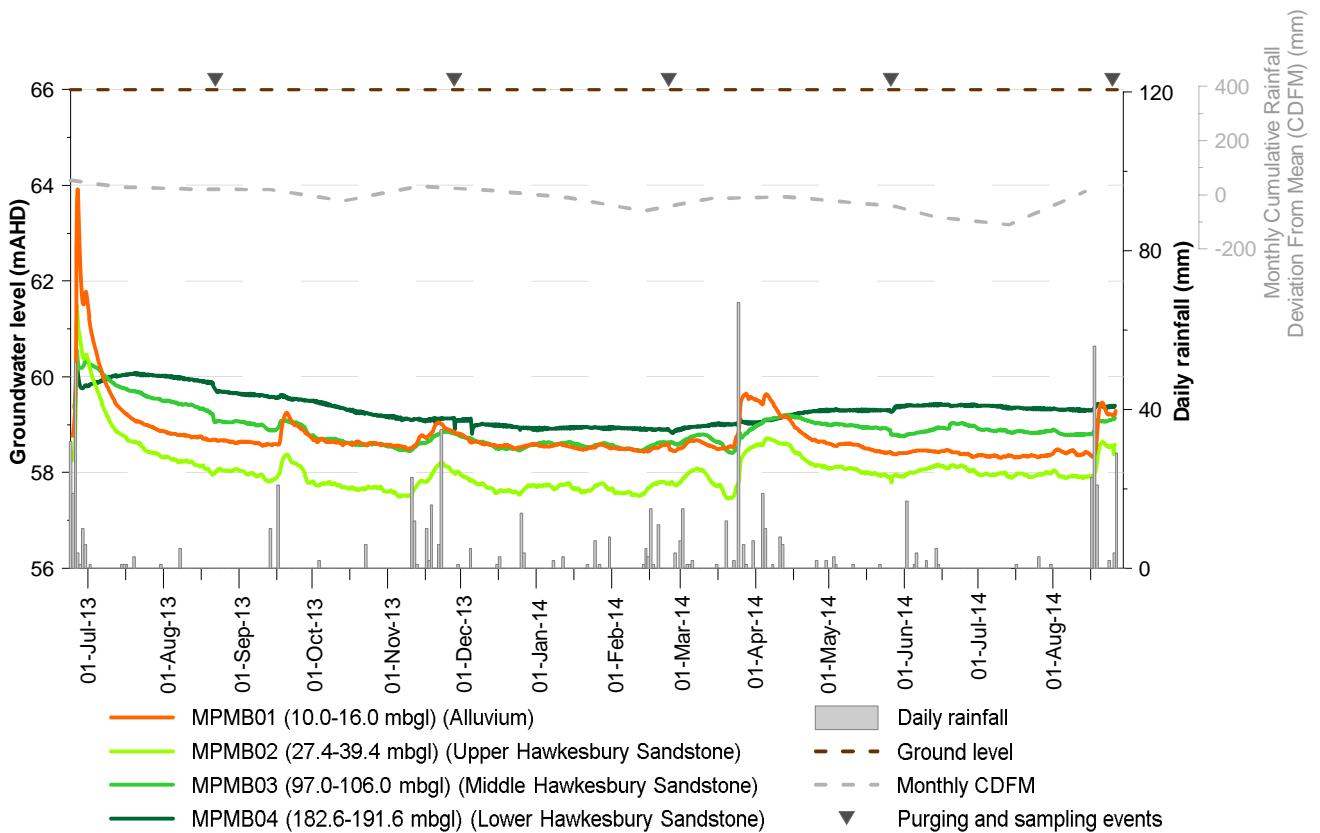
Figure A.7: RMB and MPMB monitoring bores

Figures A.7 – A.8: Nested hydrographs for the Denham Court, Menangle Park and Glenlee sites

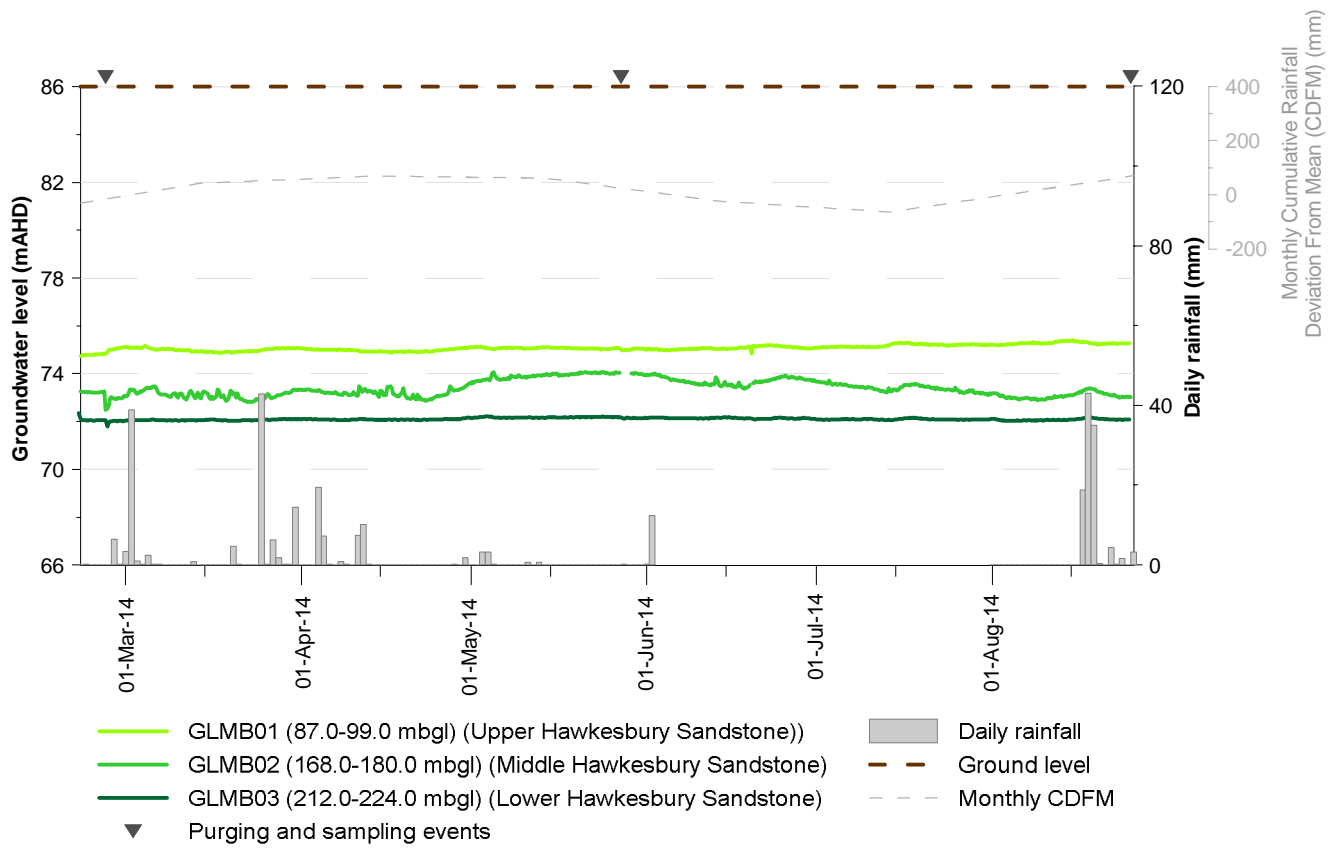
Figure A.8: GLMB monitoring bores
