Memo

Date 20 March 2015
To Nicola Fry
Copy Andrea Madden
From Carolina Sardella
Ref 2268518A-WAT-MEM-003 RevB
Subject Camden Gas Project - FY15 Q2 monitoring update - January 2015

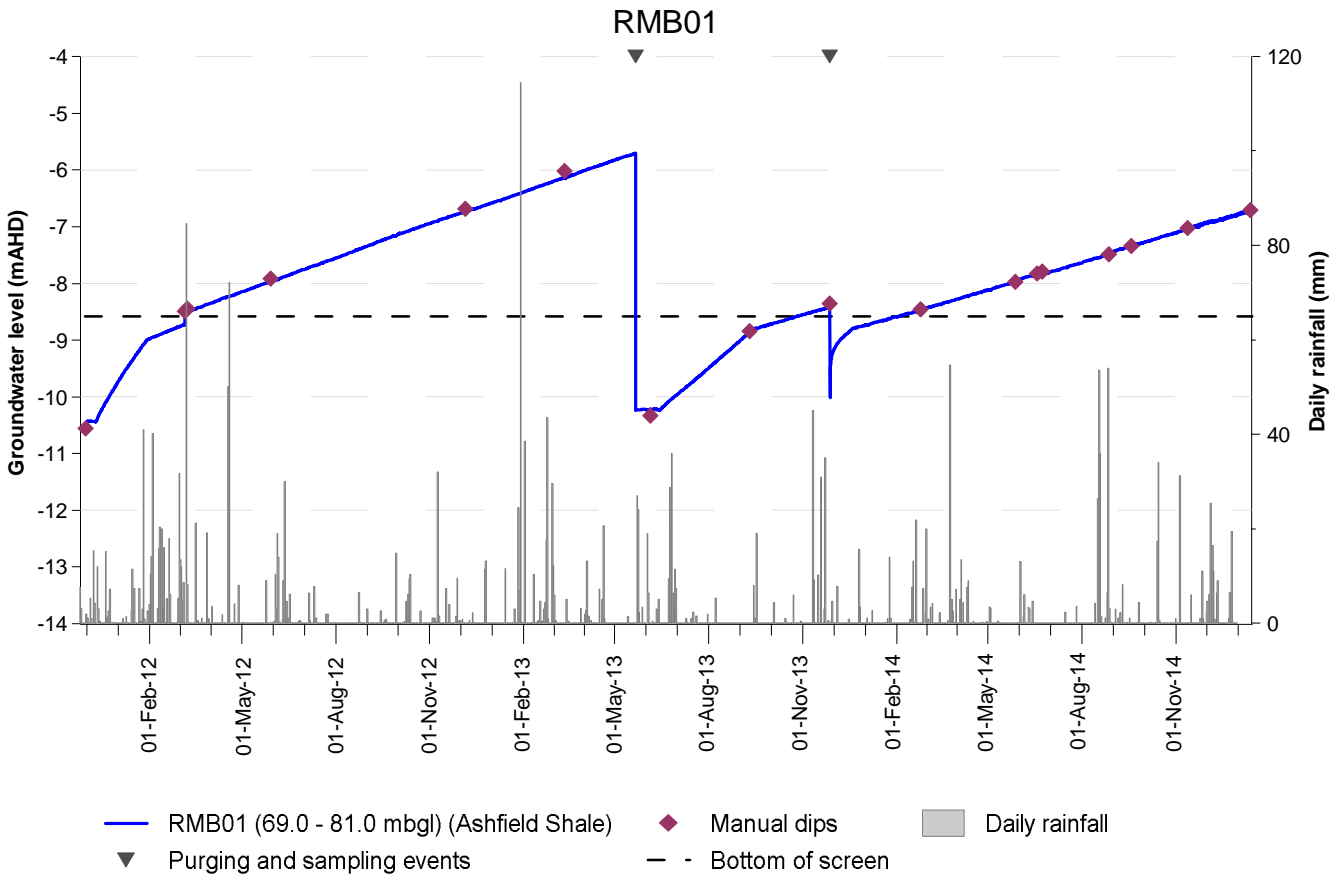
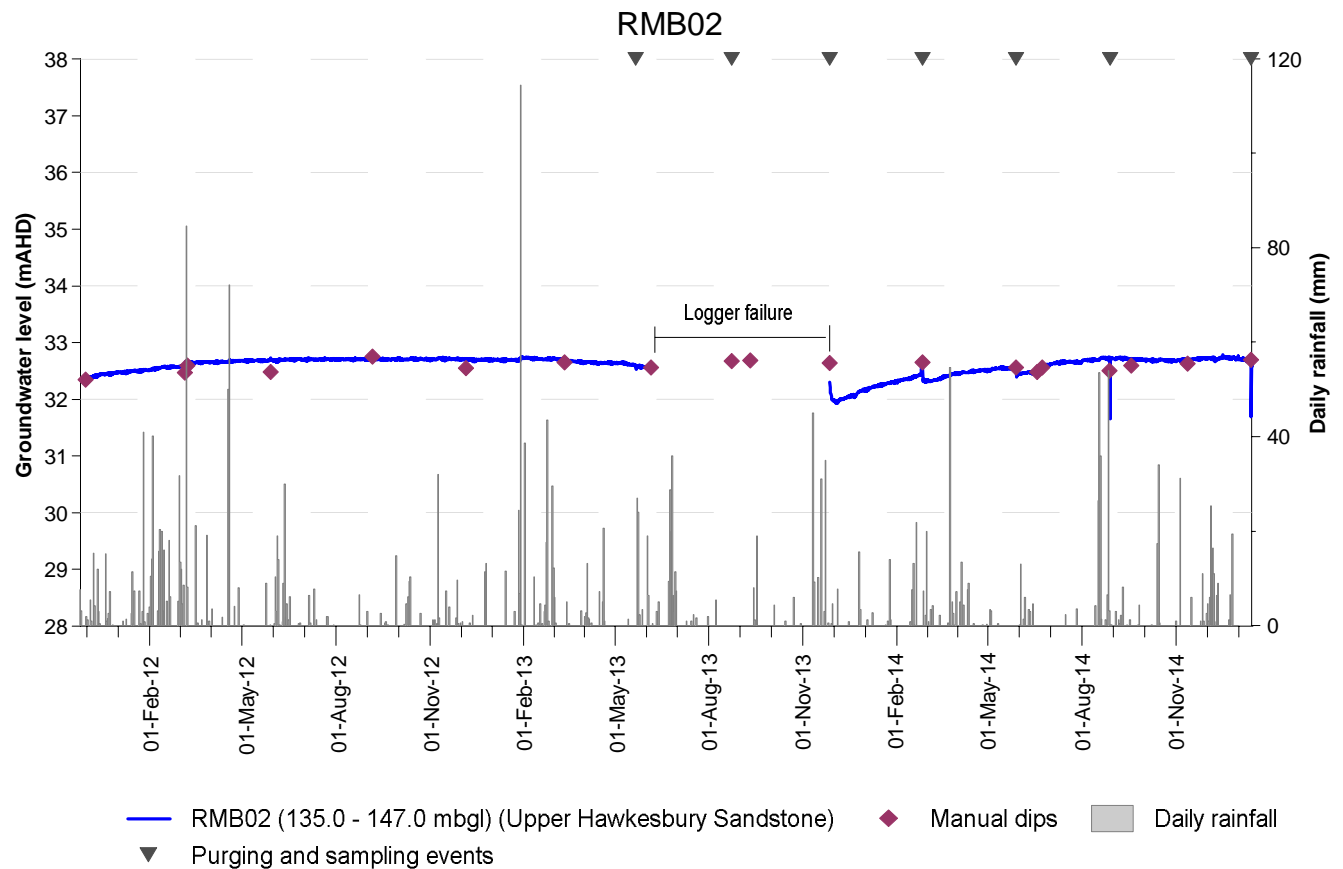
Figure A.1: RMB01 and RMB02 monitoring bores

- The fluctuating data recorded at GLMB02 appears to be natural. A replacement logger was installed at GLMB02 in October 2014 after which the water level continued to fluctuate in a similar way. Logger failure can be excluded.
- RMB01 was not sampled due to insufficient water in the monitoring bore. RMB04 continues to be dry.
