Date 9 October 2014
To Nicola Fry
Copy Andrea Madden
From Carolina Sardella
Ref 2268518A-WAT-MEM-001 RevA
Subject Camden Gas Project - FY15 Q1 Monitoring Update - October 2014

This memo presents the updated hydrographs for the Denham Court, Menangle Park and Glenlee groundwater monitoring bores to August 2014 and the water quality results for the August 2014 sampling event. It also includes September 2014 water quality results for the Nepean River sample. Full analysis and discussion of these results will be presented in the comprehensive 2015 Annual Report which will detail all groundwater and quality results from the 2014/15 monitoring period.

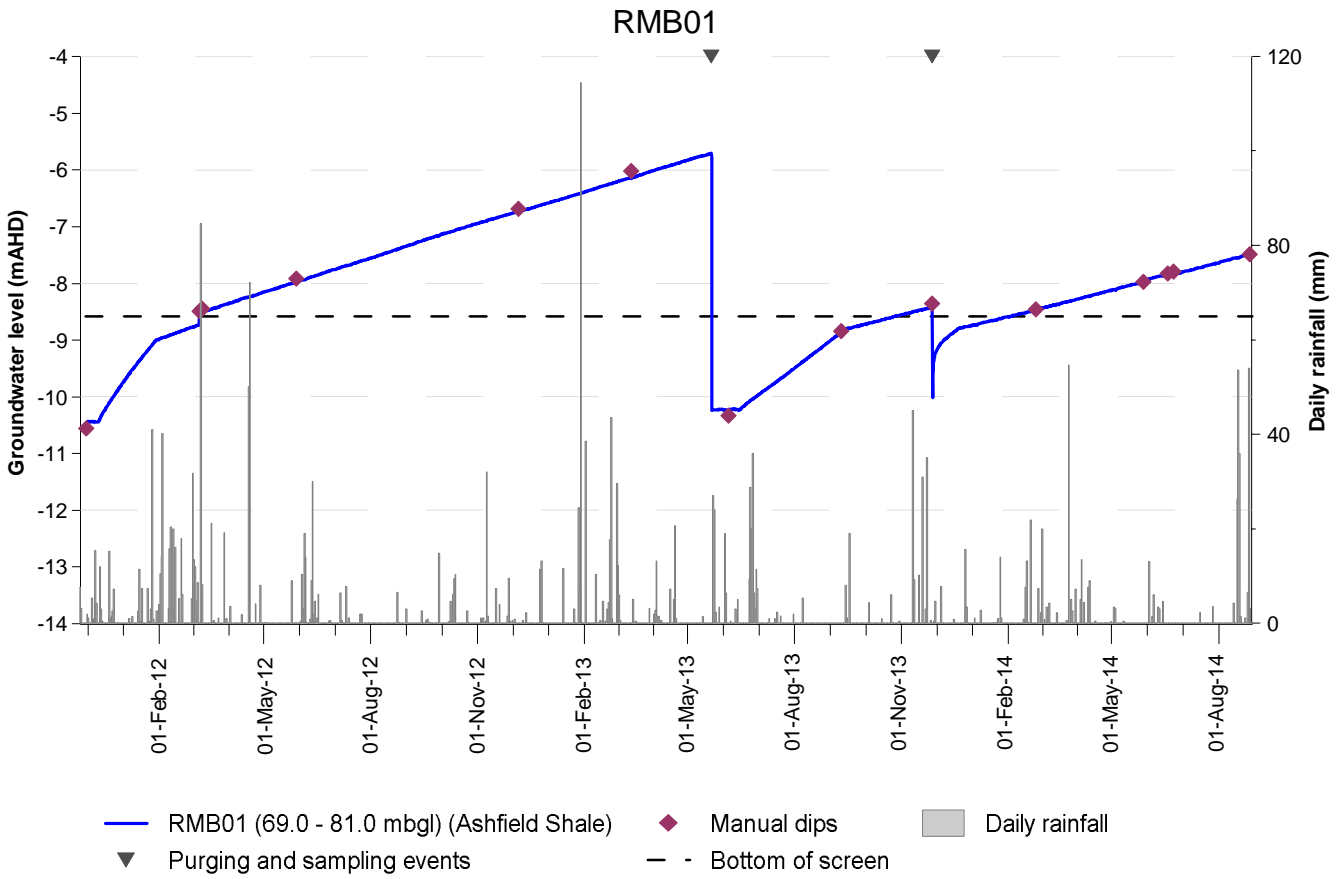
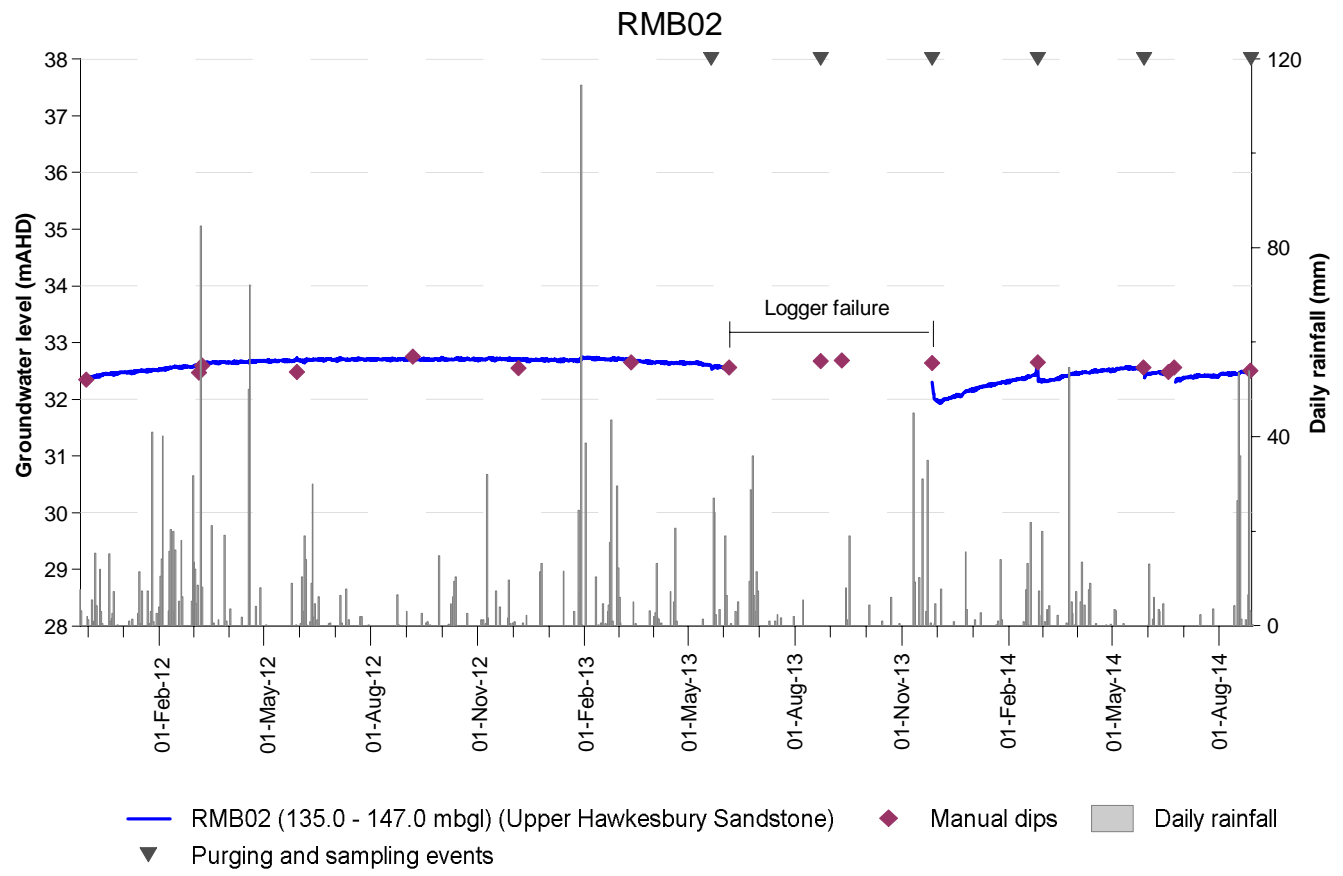
Figure A.1: RMB01 and RMB02 monitoring bores

Figures A.1 – A.2: Denham Court site hydrographs

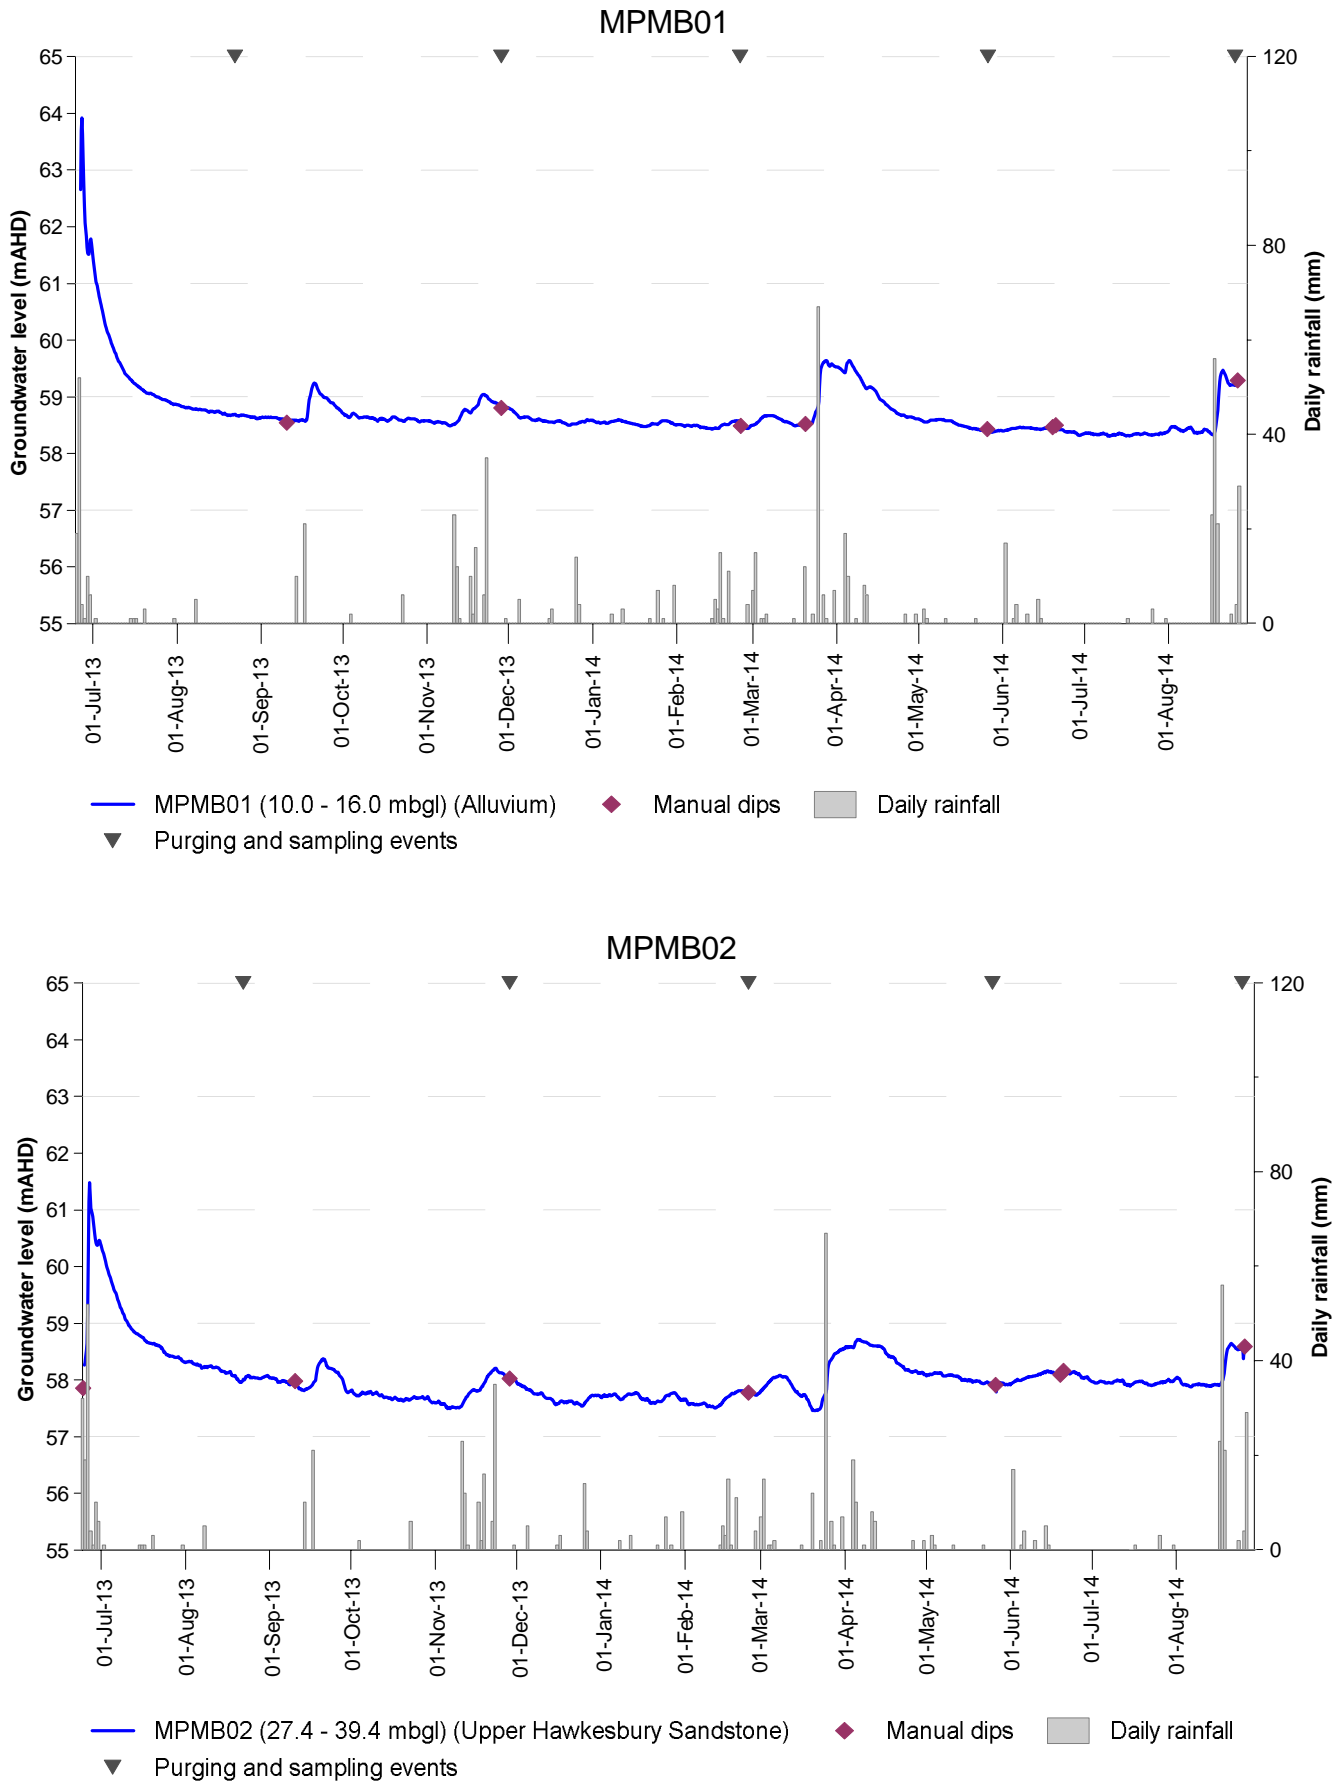
Figure A.3: MPMB01 and MPMB02 monitoring bores

Figures A.3 – A.4: Menangle Park site hydrographs

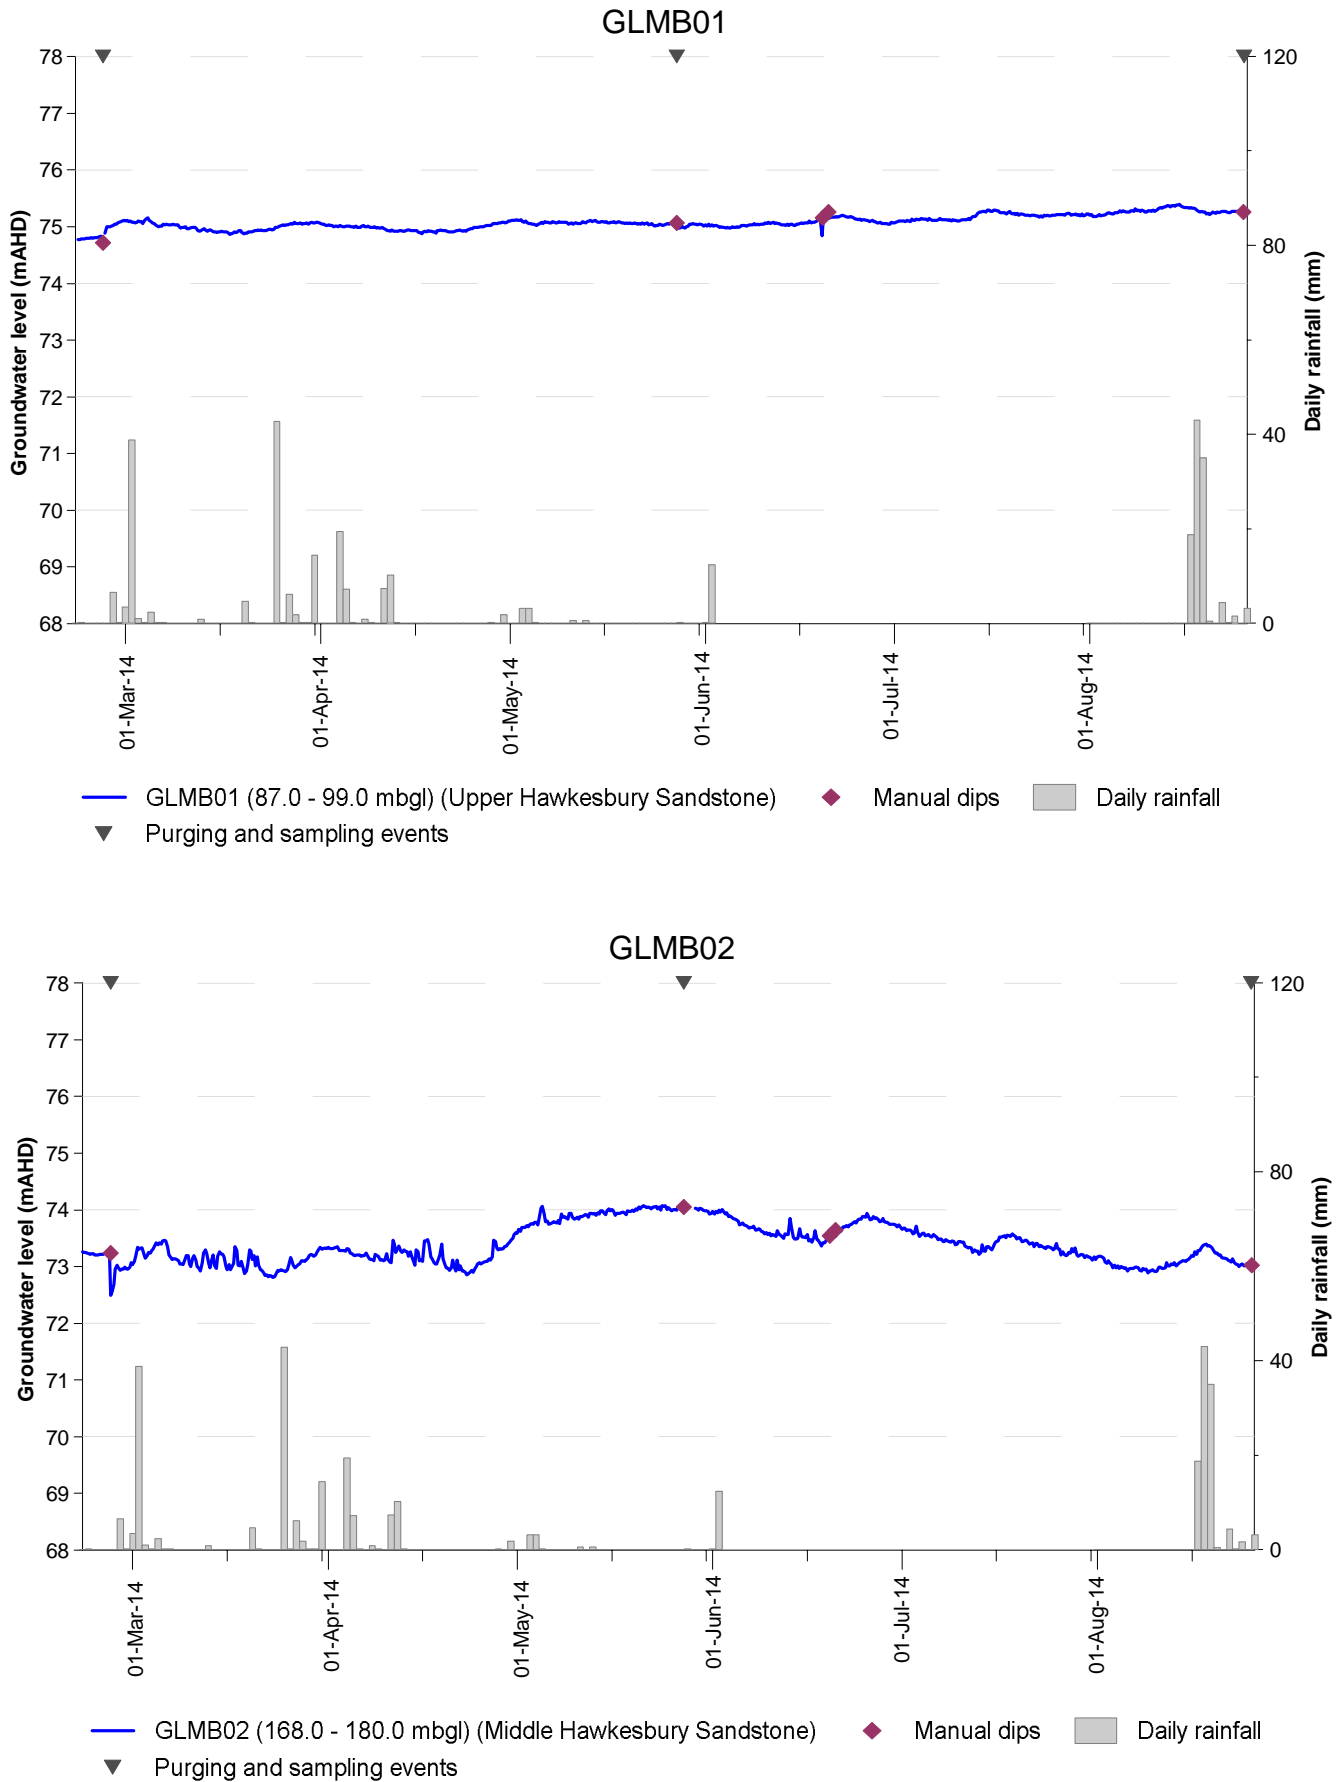
Figure A.5: GLMB01 and GLM02 monitoring bores

Figures A.5 – A.6: Glenlee site hydrographs

- The erratic nature of the data recorded at GLMB02 is being investigated (suspected logger failure).

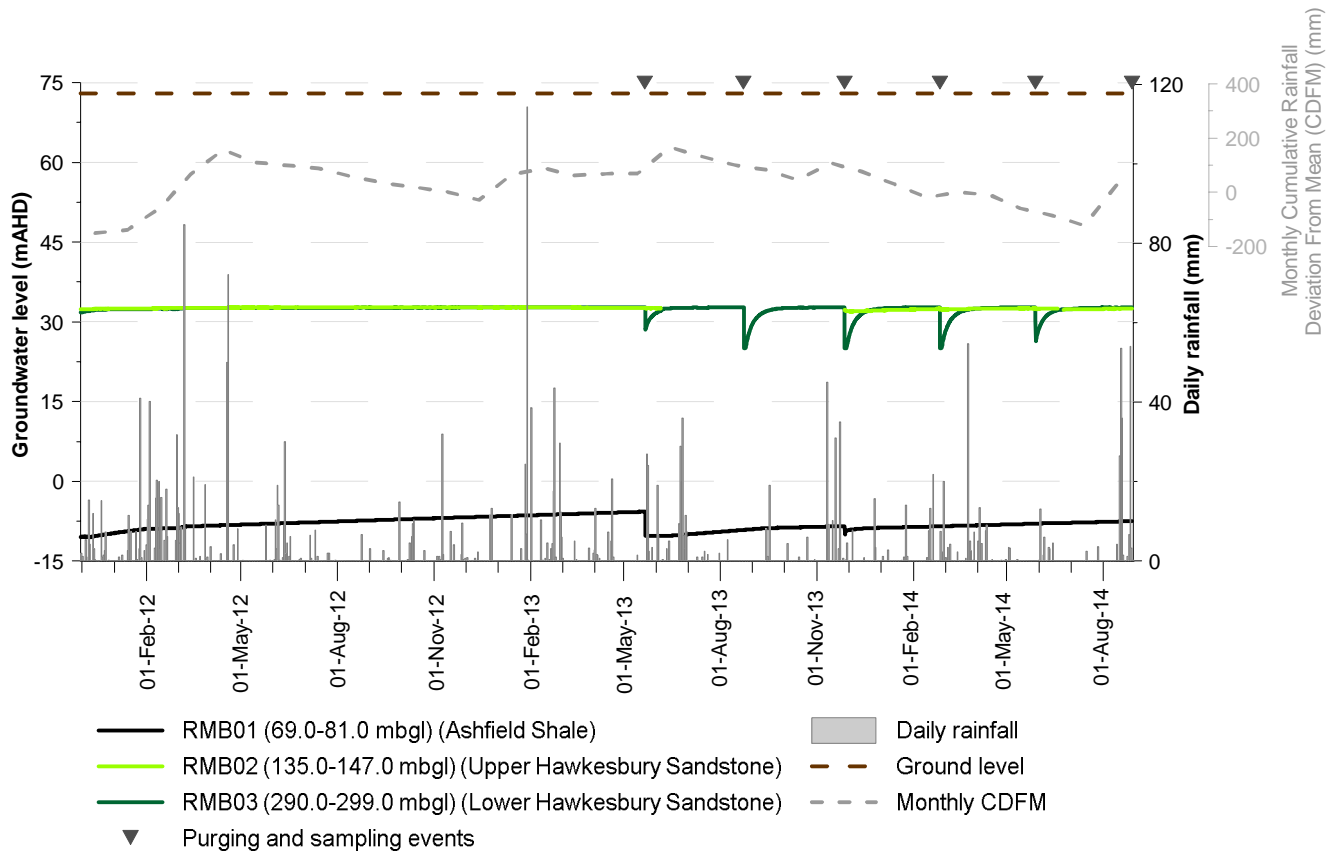
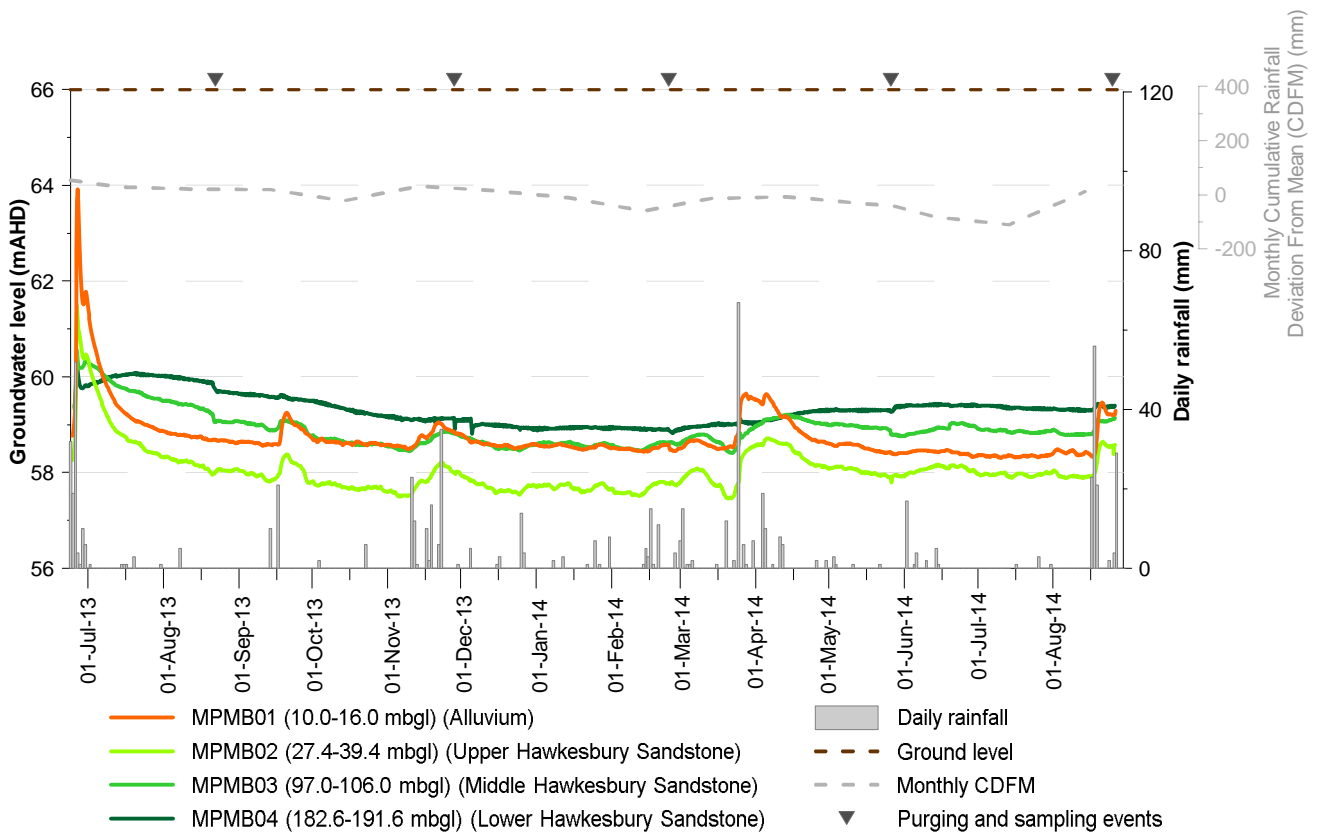
Figure A.7: RMB and MPMB monitoring bores

Figures A.7 – A.8: Nested hydrographs for the Denham Court, Menangle Park and Glenlee sites
